# Reverse Osmosis RO Membrane Housing End Cap repairs

ID: 9864

Industry: General Industry  
Application: VPF-Valves, Pipes and Fittings  
Substrate: GFRP  
Products: Belzona 1212

Customer Location: Nottinghamshire  
Application Date: July 2025

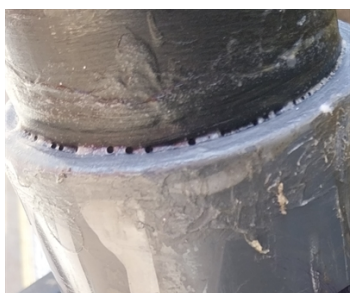
Two of the end caps on a large industrial reverse osmosis membrane housing had split, leading to a drop in pressure, big leaks and an efficiency drop in the process. The cracks needed to be fixed.

This was attempted by gluing collars of the outlets on the endcaps, which was a vain attempt and simply didn't work.

Showing porosity to glued collar, still allowing system pressure drop

All the previous "fix" was removed or scraped back, removing glue and other debris

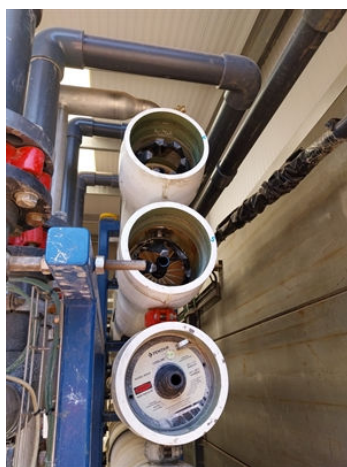
End cap receptor in RO Membrane housing

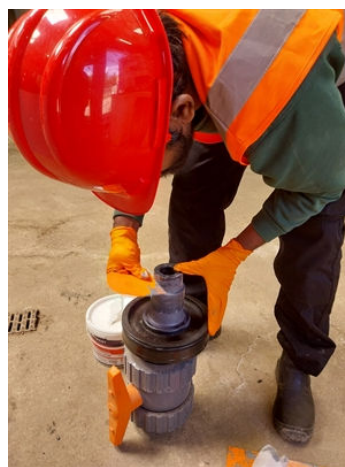
Applying Belzona 1212 to the 2 interfaces around the repair collar, previously glued, leading to a failed repair

The interfaces were cleaned and prepared with 80 grit emery and a rotating wire brush, prior to being de-greased and cleaned. Belzona 1212 was mixed as per the IFU and the interfaces were "wetted" out using a short bristled brush.

A Belzona applicator was cut to shape to help create a chamfer to the interfaces

The mixed Belzona was applied with the applicator and shaped to suit, after which all excess was removed and cleaned off

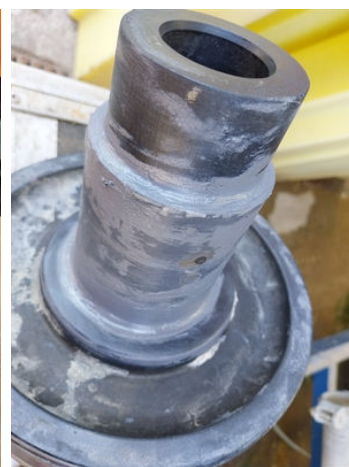
Both interfaces to the end cap fully sealed and ready to be refitted into the membrane housing

A lead time of 3 weeks was stated by the supplier for the new end caps. Belzona had the equipment back up and working within 1 hour, thanks to the surface tolerance and rapid curing Belzona 1212. Around half a 450g unit was used making the cost of each repair exceptionally low. The remainder of the unmixed unit was resealed and put back into stores for further use
