Reverse Osmosis RO Membrane Housing End Cap repairs

ID: 9864

Industry: General Industry
Application: VPF-Valves, Pipes and Fittings
Substrate: GFRP
Products: Belzona 1212

Customer Location: Nottinghamshire
Application Date: July 2025

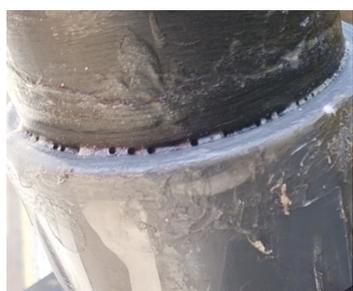
Two of the end caps on a large industrial reverse osmosis membrane housing had split, leading to a drop in pressure, big leaks and an efficiency drop in the process. The cracks needed to be fixed.

This was attempted by gluing collars of the outlets on the endcaps, which was a vain attempt and simply didn't work. Whilst on site with the Senior engineer, the Belzona Sales Engineer offered to rectify the issue there and then

Showing porosity to glued collar, still allowing system pressure drop

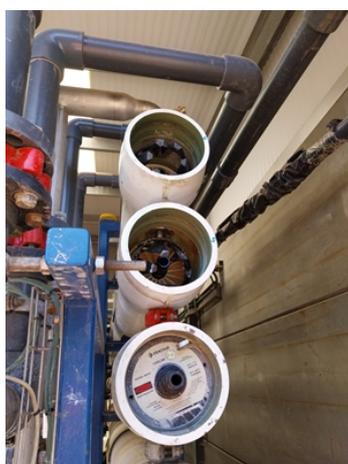
End cap receptor in RO Membrane housing

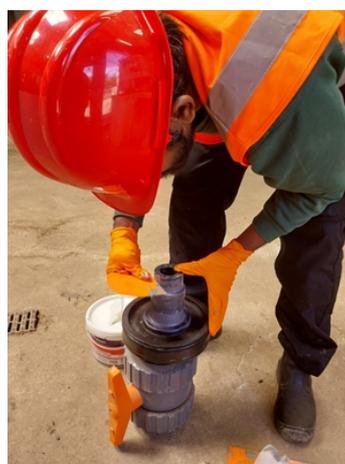
Applying Belzona 1212 to the 2 interfaces around the repair collar, previously glued, leading to a failed repair

All the previous "fix" was removed or scraped back, removing glue and other debris

The interfaces were cleaned and prepared with 80 grit emery and a rotating wire brush, prior to being de-greased and cleaned. Belzona 1212 was mixed as per the IFU and the interfaces were "wetted" out using a short bristled brush.

A Belzona applicator was cut to shape to help create a chamfer to the interfaces

The mixed Belzona was applied with the applicator and shaped to suit, after which all excess was removed and cleaned off

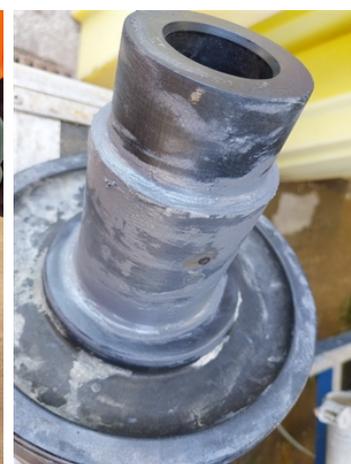
Both interfaces to the end cap fully sealed and ready to be refitted into the membrane housing

A lead time of 3 weeks was stated by the supplier for the new end caps. Belzona had the equipment back up and working within 1 hour, thanks to the surface tolerance and rapid curing Belzona 1212. Around half a 450g unit was used making the cost of each repair exceptionally low. The remainder of the unmixed unit was resealed and put back into stores for further use
