# Wet pulp screw conveyor suffering from localised erosion

ID: 9865

Industry: Food & Drink  
Application: SHM-Solids Handling Machinery

Substrate: Stainless-steel  
Products: Belzona 1311 (Ceramic R-Metal), Belzona 1391T

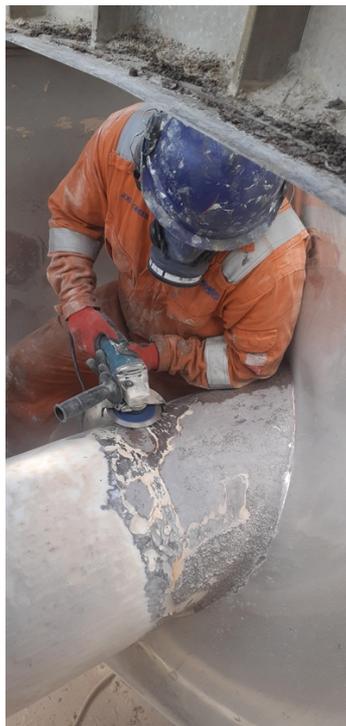
Customer has a Wet Pulp Screw Conveyor with localised areas of erosion and scoring. These defects were causing process issues and preventing the conveyor from operating at its optimum capacity

Wet pulp screw conveyor was suffering from localised erosion and scoring

The three areas of concern were located on the shaft only, affecting three separate sections between the screw flights. The total repair area was estimated to be approximately 2m<sup>2</sup>.

work commenced on in situ repair, cleaning the area with power tools

To limit disruption, the application areas were prepared using power tools only. Once prepared, the areas were thoroughly cleaned

and rendered dust-free. Any sections showing loss of profile were rebuilt back to standard using Belzona 1311, a two-component repair composite.

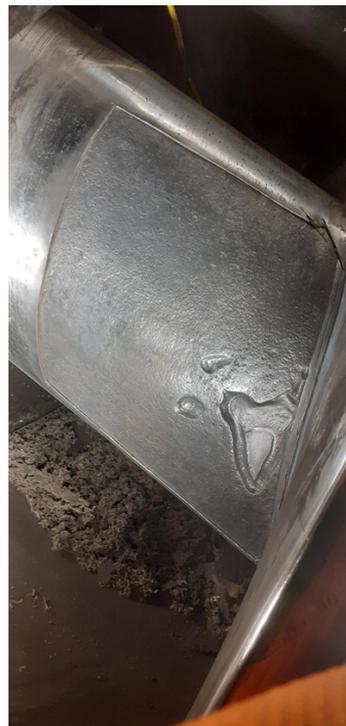
Cleaned areas exposed surface areas that required rebuilding with Belzona 1311

Finishing with two coats of 1391(T), Belzona solution

Following this, the full circumferential repair areas were reinforced using Belzona 1311 and Belzona 9341 Reinforcement Sheet, applied using a 50/50 overlap system and left to stabilise overnight.

On the following morning, the repaired areas were inspected and dressed back before receiving two coats of Belzona 1391T.
