# Wet pulp screw conveyor suffering from localised erosion

ID: 9865

Industry: Food & Drink  
Application: SHM-Solids Handling Machinery

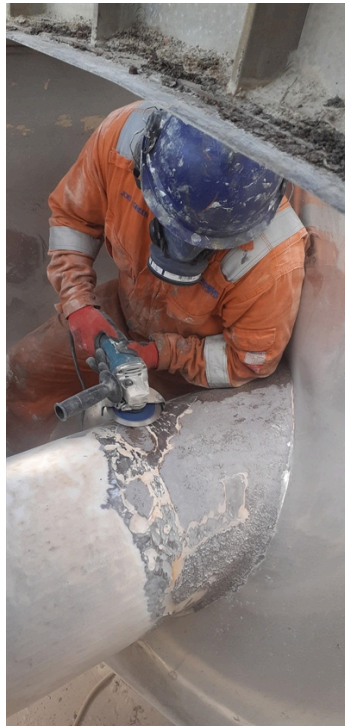
Wet pulp screw conveyor was suffering from localised erosion and scoring

The three areas of concern were located on the shaft only, affecting three separate sections between the screw flights. The total repair area was estimated to be approximately 2m<sup>2</sup>.

work commenced on in situ repair, cleaning the area with power tools

To limit disruption, the application areas were prepared using power tools only. Once prepared, the areas were thoroughly cleaned

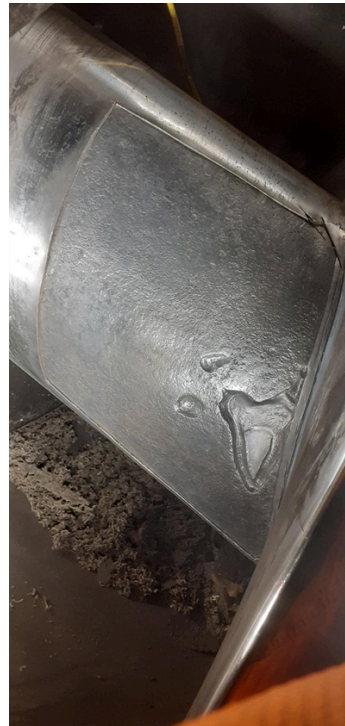
Cleaned areas exposed surface areas that required rebuilding with Belzona 1311

Finishing with two coats of 1391(T), Belzona solution

and rendered dust-free. Any sections showing loss of profile were rebuilt back to standard using Belzona 1311, a two-component repair composite.

Following this, the full circumferential repair areas were reinforced using Belzona 1311 and Belzona 9341 Reinforcement Sheet, applied using a 50/50 overlap system and left to stabilise overnight.

On the following morning, the repaired areas were inspected and dressed back before receiving two coats of Belzona 1391T.
