# Heavy Forklift Traffic concrete floor area repaired and protected

ID: 9866

Application: FPA-Floor Problem Areas

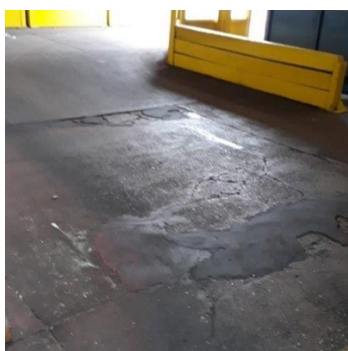
Main entrance for all forklift traffic into 4.6 hectare warehouse

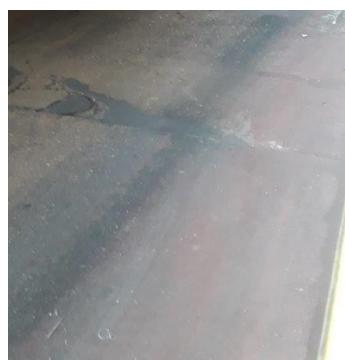
The main entrance to a large warehouse was continually pounded by constant forklift traffic entering the building. The traffic wore away the surface, eventually leading to the surface starting to break up.

The area had been "repaired" using other methods a number of times, none of which created a durable solution

Damage caused by constant heavy solid wheel handling machinery

All loose and friable materials were scraped out and the surface was vacuumed

A thin application of mixed Belzona 4911 TX conditioner was applied by short bristled brush

The Belzona 4131 MagmaQuartz was mixed in a Daines, or Forced Action mixer and applied by gloved hand

Screeding bars and finishing trowels were used to create a perfect new surface, some 3 times the compressive strength of most floor grade concretes. Also this is now impervious to water and chemicals

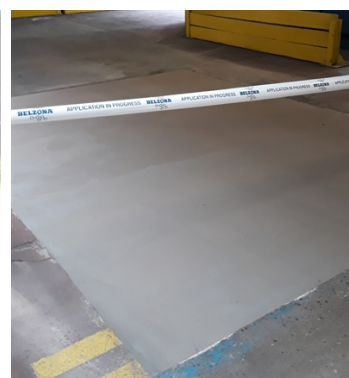
Area completely screeded at an average of 6mm using Belzona 4911 TX Conditioner and Belzona 4131 MagmaScreed
