Elevator Buckets coated to save product build up

ID: 9868

Industry: Mining & Quarrying
Application: SHM-Solids Handling Machinery

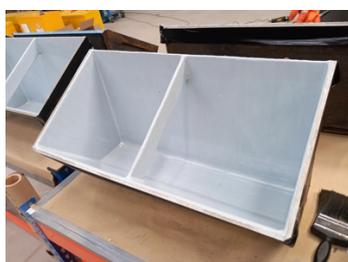
Showing blasted bucket with 1st coat of Belzona 1341 Supermetalglide

Grit blasting to SA2.5 and 70 microns, in-house in Belzona's own state-of-the-art blast booths

Cleaned and degreased with Belzona 9111

1st coat as, per spec, applied of Belzona 1341

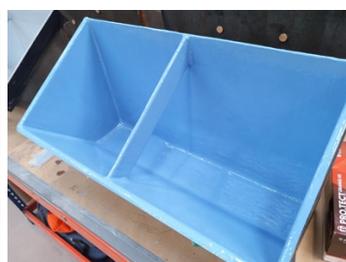
Showing 2nd coat of Belzona 1341 Supermetalglide

2nd coat, as spec, applied of Belzona 1341

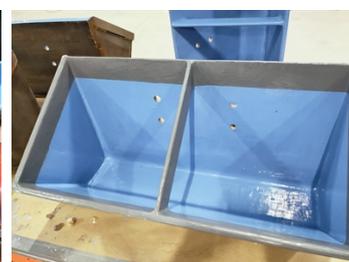
Showing completed system, including leading edge protected by Belzona 1321 Ceramic S-Metal

Leading edges coated with 2 x coats of Belzona 1321

The applied Belzona coating helped return the medium capacity back to what was expected and the Elevators were delivering much closer to the expected volumes. Also, the protection element against erosion will help prevent unnecessary downtime in the future and help save labour costs in exchanging and repairing the buckets
