# External corrosion to pipe required a long term solution

ID: 9869

Industry: Water / Wastewater  
Application: VPF-Valves, Pipes and Fittings  
Substrate: Stainless-steel  
Products: Belzona 1111 (Super Metal)

Customer Location: Preston  
Application Date: July 2025

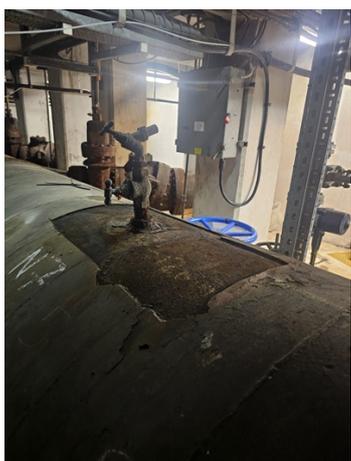
The high lift pumping station (HLPS) Delivery Water Main was situated within a culvert. Over time, a section of this main has thinned due to external corrosion. Originally, the wall thickness was believed to be 12mm, but the area at nozzle had reduced to approximately 7mm

Pipe at nozzle was suffering from external corrosion

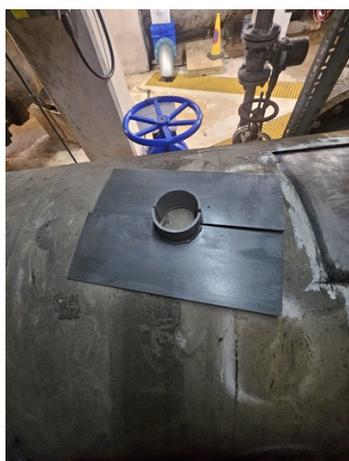
Cold applied plate bonding was selected as the long-term protection solution

The area was prepared using grinders and specialist surface preparation 110v powered tools.

Once the substrate was at an acceptable level, a prefabricated, rolled and blasted plate was dry fitted to the area, ensuring no adjustments were required.

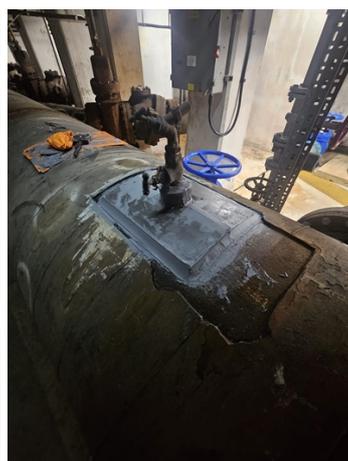
The pre-fabricated plate was fitted around the nozzle and loaded with Belzona 1111

Next, Belzona 1111 was applied directly to both the substrate and plate(s) using a stiff brush first to eliminate air entrapment. The plate(s) were then loaded with Belzona® 1111 in a manner to allow all material to evenly spread across the plate and substrate during bonding.

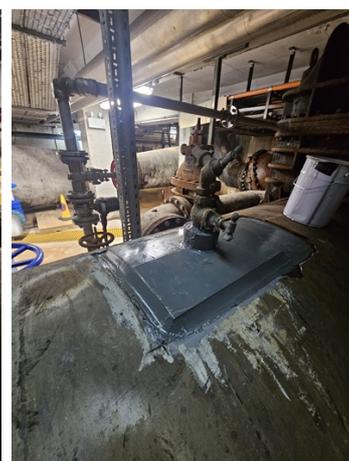
Belzona 1111 was filleted, presenting a smooth finish and completing the long term protection solution

When all excess material had protruded from all 4 sides, Belzona 1111 product was filleted off the plate, leaving a smooth finish.

Plate bonding using Belzona 1111 restored integrity to the pipe and offered a long term solution to the external corrosion issue that the customer was facing
