External corrosion to pipe required a long term solution

ID: 9869

Industry: Water / Wastewater
Application: VPF-Valves, Pipes and Fittings
Substrate: Stainless-steel
Products: Belzona 1111 (Super Metal)

Customer Location: Preston
Application Date: July 2025

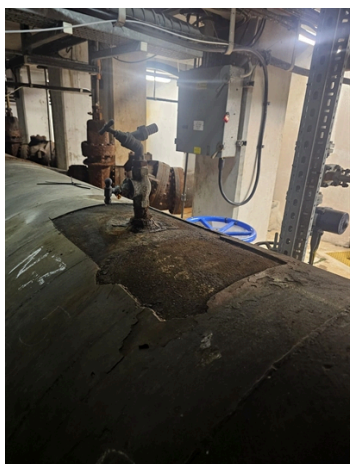
The high lift pumping station (HLPS) Delivery Water Main was situated within a culvert. Over time, a section of this main has thinned due to external corrosion. Originally, the wall thickness was believed to be 12mm, but the area at nozzle had reduced to approximately 7mm

Pipe at nozzle was suffering from external corrosion

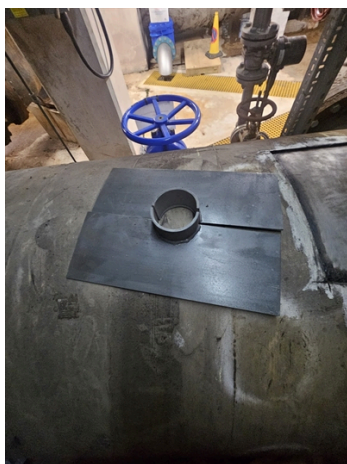
Cold applied plate bonding was selected as the long-term protection solution

The area was prepared using grinders and specialist surface preparation 110v powered tools.

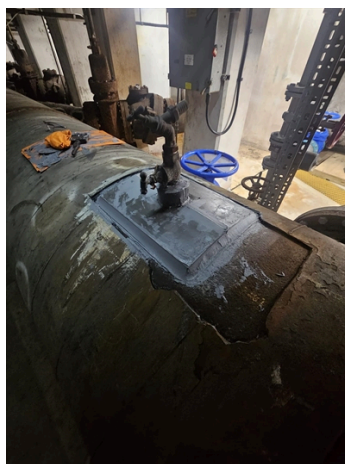
The pre-fabricated plate was fitted around the nozzle and loaded with Belzona 1111

Once the substrate was at an acceptable level, a prefabricated, rolled and blasted plate was dry fitted to the area, ensuring no adjustments were required.

Next, Belzona 1111 was applied directly to both the substrate and plate(s) using a stiff brush first to eliminate air entrapment. The plate(s) were then loaded with Belzona® 1111 in a manner to allow all material to evenly spread across the plate and substrate during bonding.

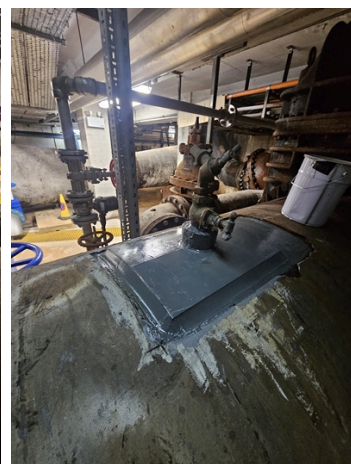
Belzona 1111 was filleted, presenting a smooth finish and completing the long term protection solution

When all excess material had protruded from all 4 sides, Belzona 1111 product was filleted off the plate, leaving a smooth finish.
