# Ball mill walls repaired with Belzona

ID: 9870

Industry: Mining & Quarrying  
Application: SHM-Solids Handling Machinery

Substrate: Carbon steel  
Products: Belzona 1121 (Super XL-Metal), Belzona 1511 (Super HT-Metal)

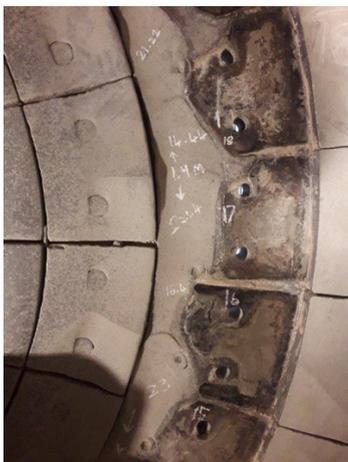
On removing the large wear plates inside a large Ball Mill, the internal surfaces of parts of the ball mill were showing severe wear, where the constant grinding had led to dust getting through the gaps of the wear plates and eroding the actual surface of the ball mill walls and end faces

Showing large area of wear, once the wear plates have been removed

The target application areas were Grit Blasted to SA2.5 at 75 microns.

The Belzona 1511 was mixed to spec and was wetted out to the target areas using short bristled brushes

Belzona 1511 was applied using applicators to bring the work substrate back to the required profile.

A final application of Belzona 1121 was carried out and made ready for the installation of the new wear plates

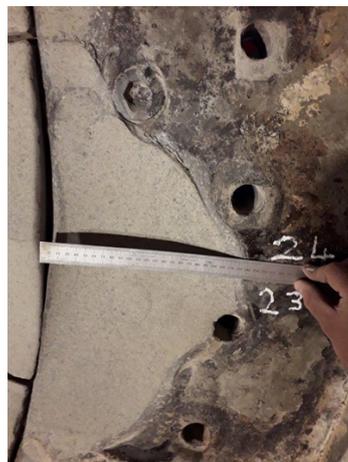
Showing depth of wear against Applications Team Straight edge

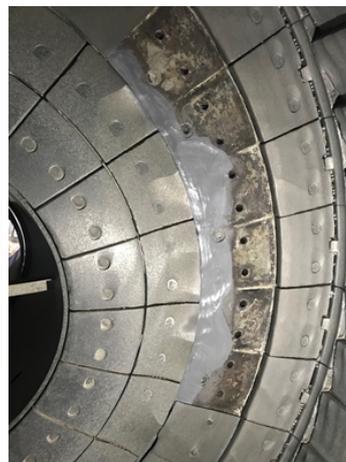
Same area as Photo 1, but now filled and ready for installation of wear plates

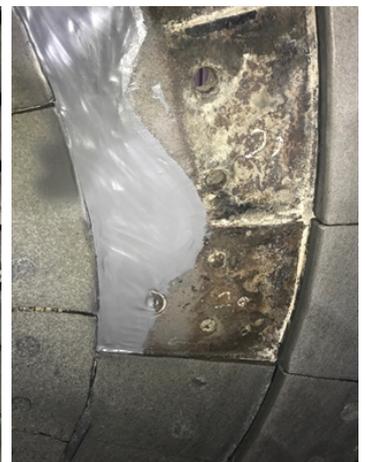
Same area as Photo 2, showing repair
