Expansion joint improved to save damage to Fork Lifts

ID: 9871

Industry: *Buildings & Structures*
 Application: *FPA-Floor Problem Areas*
 Substrate: *Carbon steel*
 Products: *Belzona 2211 (MP Hi-Build Elastomer), Belzona 2911 (Elastomer QD Conditioner)*

Customer Location: *Doncaster*
 Application Date: *January 2025*

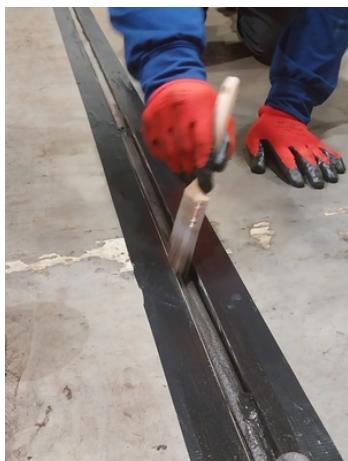
Joint taped and the application of Belzona 2911 Conditioner

Apply Belzona 2911 conditioner as per spec

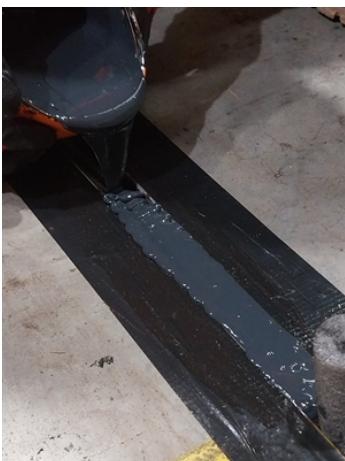
Pouring in the Belzona 2211 Hi Build Elastomer

Mix and pour Belzona 2211 Hi-build to complete the finished application

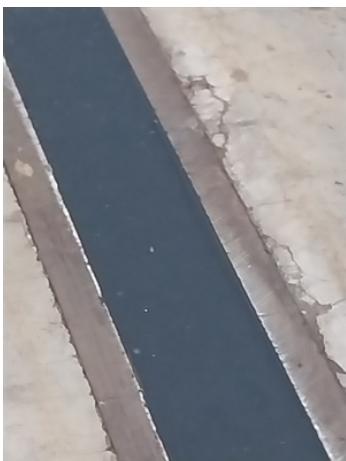
Expansion joint filled and tape removed

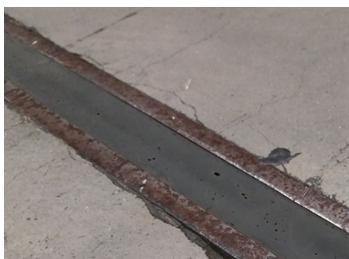
Trial Joint almost 12 months later

Fork Lift repair and maintenance costs are expected to reduce drastically, thanks to the Belzona application. Almost 1 year on, the joint has held perfectly well. The company are now considering carrying out the same repair to a further 4km+
