Boiler House External areas

ID: 9873

Industry: Buildings & Structures
Application: FPA-Floor Problem Areas
Substrate: Concrete
Products: Belzona 3131 (WG Membrane), Belzona 3931 (WG Membrane Conditioner), Belzona 4131 (Magma-Screed), Belzona 4911 (Magma TX Conditioner)

Customer Location: Stamford
Application Date: March 2025

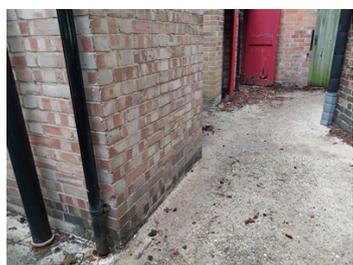
Showing areas of possible leakage through to the underground boiler house

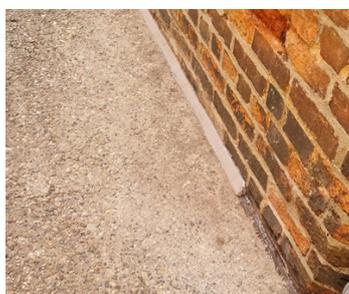
Flaunch applied at 35mm 45 degrees slope to ensure there is no square edge termination point to the Belzona 3131

All flaunching completes

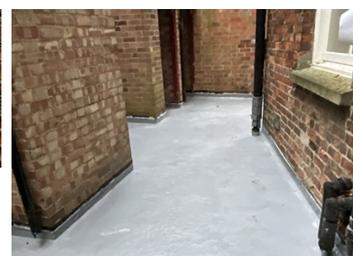
Completed with 2 x coats Belzona 3131
