Belzona repairs heavy traffic concrete floor

ID: 9878

Industry: General Industry
Application: FPA-Floor Problem Areas
Substrate: Concrete
Products: Belzona 4131 (Magma-Screed), Belzona 4911 (Magma TX Conditioner)

Customer Location: Mansfield
Application Date: July 2024

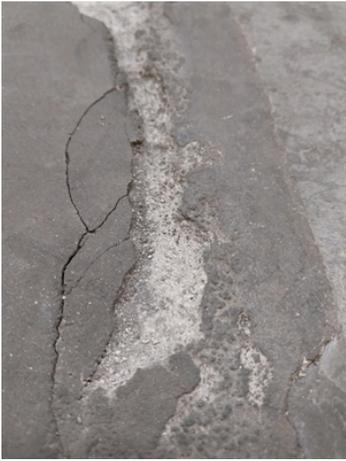
Part of the main repair, a previous application failed after only 6 weeks. This was their fourth attempt at repairing this floor area

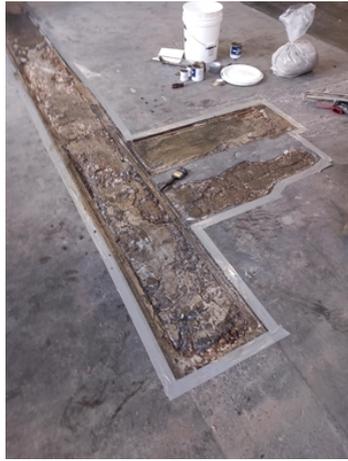
Old, loose concrete and failed repair, no further excavation required. Area coated with Belzona 4911 (TX Conditioner)

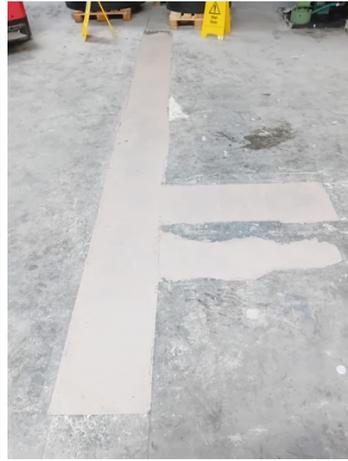
Application of Belzona 4131 completed by the company's own staff, under supervision of the Belzona Area Sales Engineer

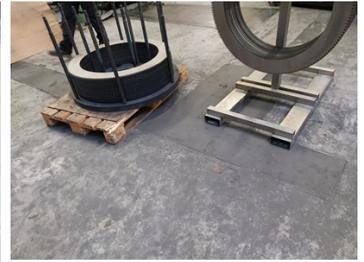
Shown here, in every day use, some 6 months on

After 5 failed attempts, the work was checked on after 6 months. No defects were found, apart from minor cracking to the concrete adjacent to the repair. The interface is still intact and the small cracks are in the parent concrete due to movement in the area. The

repair remains solid, flat, level and safe. The Engineer is now attracting a price from a Belzona Experienced Contractor to pursue all the other areas of damage
