Belzona solution difficult racking issue

ID: 9879

Industry: General Industry
Application: FPA-Floor Problem Areas
Substrate: Concrete
Products: Belzona 4111 (Magma-Quartz), Belzona 4911 (Magma TX Conditioner)

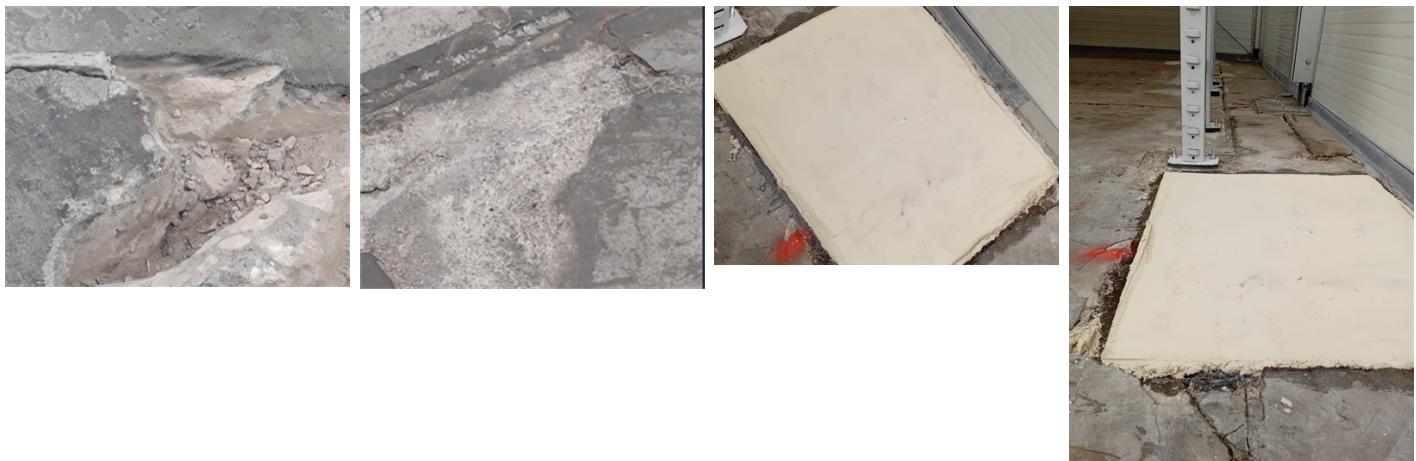
Floor failed where racking was due to be placed

Opening up into the area of repair

This shows the 500mm x 500mm pad constructed from Belzona 4111

A further view of the new pad

The area was marked out and a frame was set to level. This frame was coated with Belzona 9411 release agent

The area was made rough, using cordless grinders with flap wheels and the area was vacuumed and cleaned

Belzona 4911 TX Conditioner was applied to the area as per the Belzona 4911 Instructions for Use

Following this, the Belzona 4111 resins were mixed in a receptacle. The Belzona 4111 aggregate was added and mixed well

This was applied inside the frame and compressed/levelled using a finishing trowel.

Any unfinished external areas were also repaired using the system as above to leave a solid, level pad for the bolting of the racking to take place
