# Expansion joint repaired using Belzona

ID: 9880

Industry: General Industry Customer Location: Mansfield  
Application: FPA-Floor Problem Areas Application Date: July 2024  
Substrate: Concrete  
Products: Belzona 2211 (MP Hi-Build Elastomer), Belzona 2911 (Elastomer QD Conditioner)

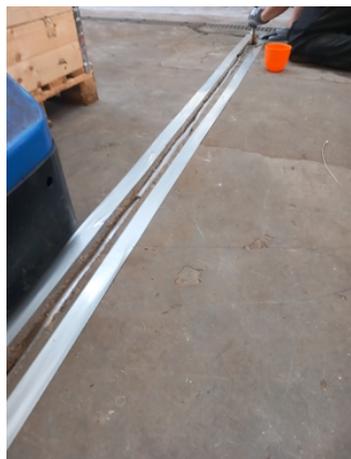
Area demarcated, prepared and cleaned

Remove all loose and friable material from the target area

Vacuum the joint to remove dust and debris

Tape the sides of the joint to help deliver a clean application line

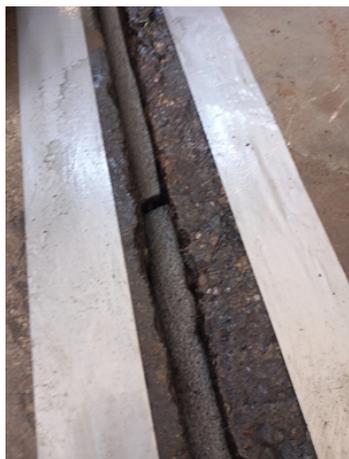
Foam Backer rod installed and Belzona 2911 (Elastomer QD Conditioner) applied

Offer in the foam backer rod do a depth of half the width of the joint

Apply a coat of Belzona 2911 (Elastomer QD Conditioner) with a short bristled brush

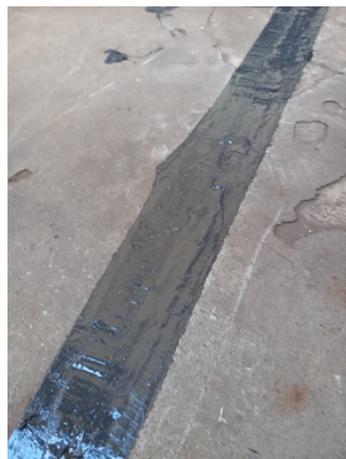
Expansion joint complete and tape removed

Mix the Belzona 2211 (MP Hi-Build Elastomer) in a mixing bowl and steadily pour the elastomer in, avoiding the inclusion of air bubbles

Use an applicator to smooth out the application and remove all tape

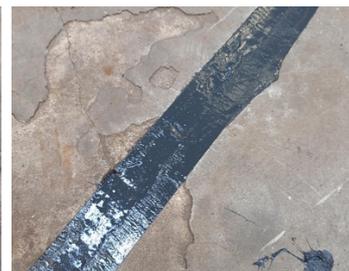
Problem solved with the Belzona 2211 (MP Hi-Build Elastomer) ensuring an even run for the hand pallet trucks
