Belzona 5815 Non-Skid Parking Area

ID: 9890

Industry: *Chemical & Petrochemical*
 Application: *TCC-Tanks and Chemical Containment Areas*
 Substrate: *Concrete*
 Products: *Belzona 5815*

Customer Location: *Decatur, AL*
 Application Date: *March 2024*

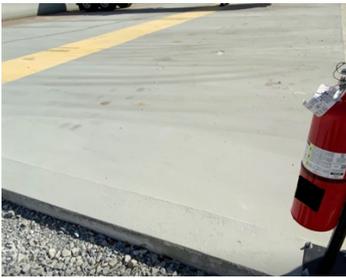
This area had only been coated less than a year. The coating had started to peel away from the concrete surface in sheets causing this area to be non-compliant for chemical tanker storage.

Before picture of the current coating that has delaminated in many areas.

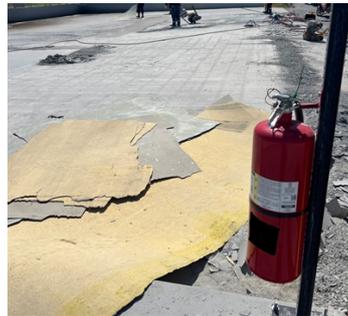
Removal process of the current coating. Look how this coating just peeled away in sheet. This was caused from poor surface preparation.

We used walk behind grinders to remove the current coating and peeled away by hand most of the remaining coating. Once the coating was removed we prepped the surface with diamond bit grinders to scarify the concrete surface. Then we pressure washed to remove any loose debris. Once the area was dry we applied two coats of Belzona 5815 and light aggregate to create non-slip surface for the tanker drivers.

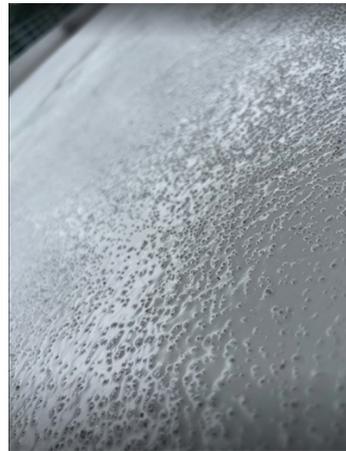
Close up picture of Belzona 5815 with added aggregate for a non-skid finish.

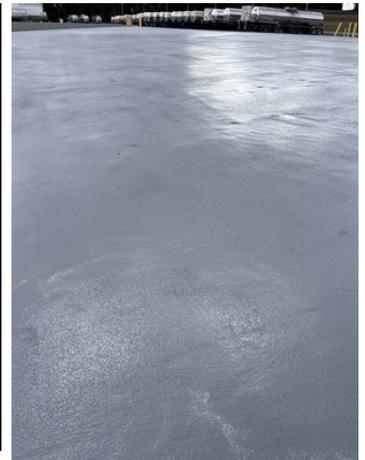
Final result of using Belzona 5815 with aggregate in this truck parking area.

Since this containment is a dry containment Belzona 5815 was chosen due to the adhesion and flexibility rating to expand and contract with the environment.
