# Belzona 5815 Non-Skid Parking Area

ID: 9890

Industry: Chemical & Petrochemical  
 Application: TCC-Tanks and Chemical Containment Areas  
 Substrate: Concrete  
 Products: Belzona 5815

Customer Location: Decatur, AL  
 Application Date: March 2024

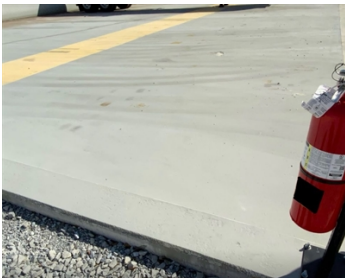
*This area had only been coated less than a year. The coating had started to peel away from the concrete surface in sheets causing this area to be non-compliant for chemical tanker storage.*

Before picture of the current coating that has delaminated in many areas.

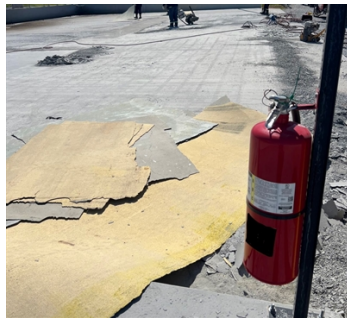
Removal process of the current coating. Look how this coating just peeled away in sheet. This was caused from poor surface preparation.

We used walk behind grinders to remove the current coating and peeled away by hand most of the remaining coating. Once the coating was removed we prepped the surface with diamond bit grinders to scarify the concrete surface. Then we pressure washed to remove any loose debris. Once the area was dry we applied two coats of Belzona 5815 and light aggregate to create non-slip surface for the tanker drivers.

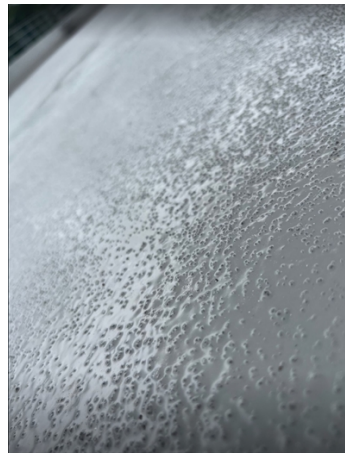
Close up picture of Belzona 5815 with added aggregate for a non-skid finish.

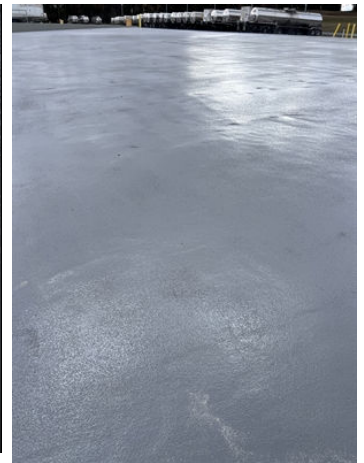
Final result of using Belzona 5815 with aggregate in this truck parking area.
