BELZONA SOLUTIONS FOR REBUILDING & COATING LUBE COOLER/END COVER

ID: 9891

Industry: Oil & Gas
Application: HEX-Heat Exchangers
Substrate: Bronze
Products: Belzona 1311 (Ceramic R-Metal), Belzona 1391 (Ceramic HT), Belzona 9111 (Cleaner Degreaser)

Customer Location: Abu Dhabi, United Arab Emirates
Application Date: March 2022

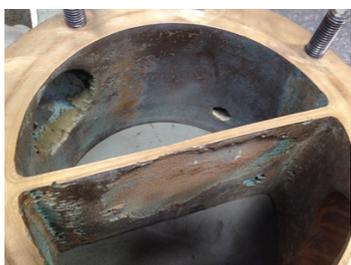
One of our offshore clients reported a case of corrosion affecting their heat exchanger (HEX) equipment. The root cause was identified as prolonged exposure to the highly humid and saline atmosphere typical of offshore environments. Such conditions significantly accelerate material degradation, leading to concerns regarding the structural integrity, safety, and long-term operational reliability of the equipment.

Degraded heat exchanger due to corrosion.

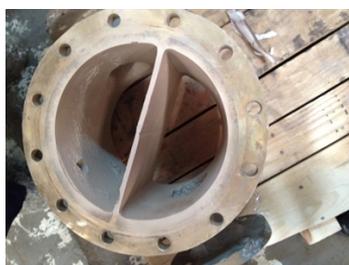
Surface preparation was done through grit blasting to SA 2.5 standard.

The application was carried out in accordance with Belzona Know-How System Leaflets HEX-1 and HEX-3, ensuring compliance with industry best practices for corrosion protection and extended equipment life. Surface preparation was done through grit blasting to SA 2.5 standard, followed by cleaning using Belzona 9111 (Cleaner Degreaser). Damaged areas were rebuilt with Belzona 1311 (Ceramic R-Metal), and the equipment was then coated with two layers of Belzona 1391 (Ceramic HT) for long-term protection.

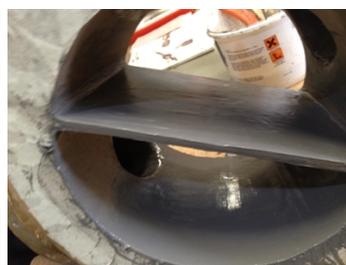
After cleaning the surface with Belzona 9111 (Cleaner Degreaser), Belzona 1311 (Ceramic R-Metal) was used to rebuild the damaged areas.

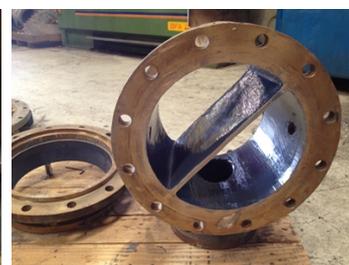
The equipment was subsequently coated with two layers of Belzona 1391 (Ceramic HT) to ensure long-term protection.

During the inspection carried out in August 2024, the Belzona coating was observed to be in excellent condition, with no evidence

of discoloration, degradation, or loss of protection
