Belzona 1321 Provides New Life to Heat Exchanger Tube Sheet

ID: 9892

Industry: Buildings & Structures
Application: HEX-Heat Exchangers
Substrate: Carbon steel
Products: Belzona 1111 (Super Metal), Belzona 1321 (Ceramic S-Metal)

Customer Location: Birmingham, AL
Application Date: March 2025

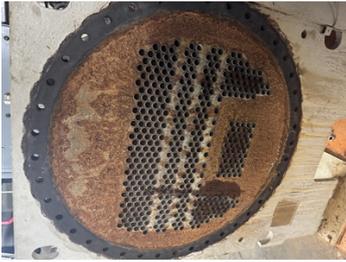
This 20 year old tube sheet was facing significant wear and corrosion following many years in service. Our customer was looking to restore the existing tube sheet to protect it and keep it running in the future.

Before / Unrestored

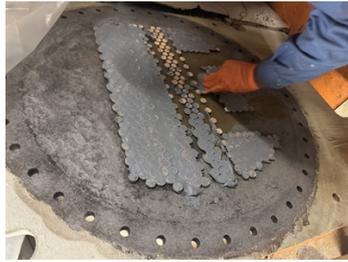
In Repair Process: Following Sandblasting, corks are placed and Belzona 1111 is used to rebuild low areas.

We sponge blasted the steel sheet and end cap to achieve the required white metal profile. We proceeded to place corks in the tubes. Belzona 1111 was applied to the low areas on the sheet to recreate the surface needed for coatings. Two coats of Belzona 1321 were applied to the tube sheet and end cap. Air was used to blow out the corks on the other side.

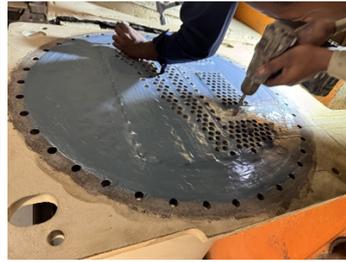
After (2) coats of Belzona 1321, the corks are then drilled out and the tubes are touched up.

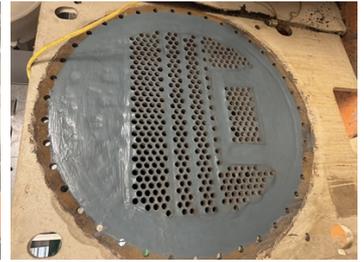
Final product, Belzona 1321 applied and good to go.
