Floating roof repair.

ID: 9896

Application: TCC-Tanks and Chemical Containment Areas

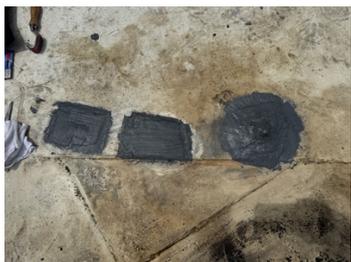
The floating roof developed a couple of corrosion holes on the plates.

Belzona 1212 Tank patches view 1.

The area was prepped as best as possible by a hand metal brush, A Belzona 9611 emergency product was used to temporarily plug the hole.

After cured a kit with a mesh and Belzona 1212 was used to complete the repair.

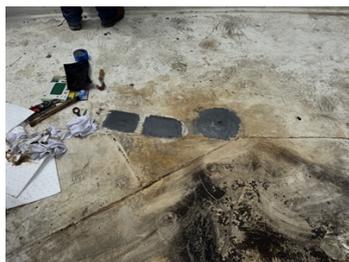
Belzona 1212 Tank patches view 2

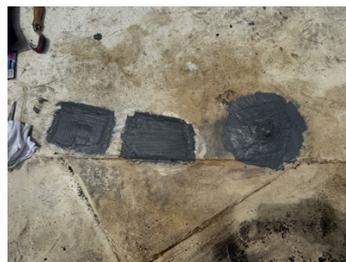
Belzona 1212 Tank patches view 3

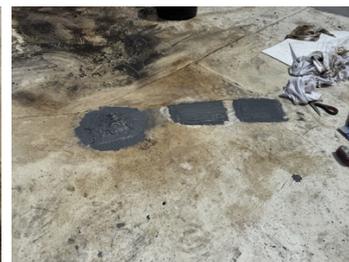
Belzona 1212 Tank patches view 4
