Belzona Rebuilds and Protects Floor Decks in Mill Area

ID: 9899

Industry: Sugar
Application: FPA-Floor Problem Areas
Substrate: Concrete
Products: Belzona 4124 (Bulkfill), Belzona 4311 (Magma CR1), Belzona 5811 (Immersion Grade)

Customer Location: South Florida
Application Date: July 2025

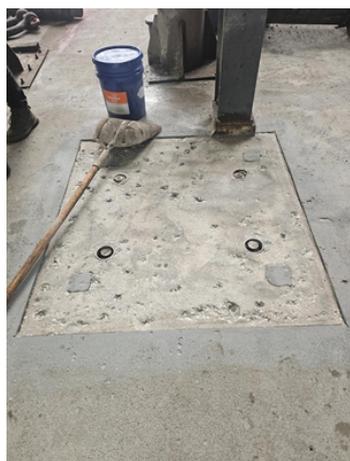
Damaged section after surface preparation was completed.
