Belzona Rebuilds and Protects Floor Decks in Mill Area

Industry: Sugar
Application: FPA-Floor Problem Areas
Substrate: Concrete
Products: Belzona 4124 (Bulkfill), Belzona 4311 (Magma CR1), Belzona 5811 (Immersion Grade)

Customer Location: South Florida
Application Date: July 2025

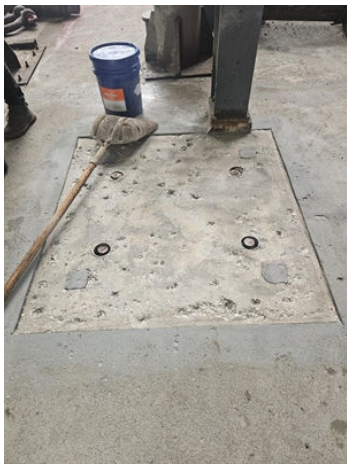
Damaged section after surface preparation was completed.

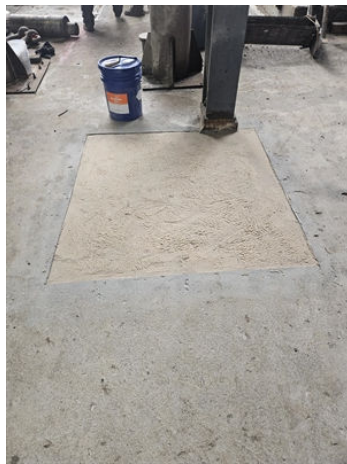
Damaged section rebuilt using Belzona 4124.

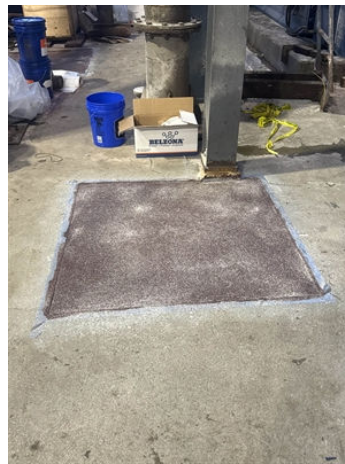
Rebuilt section after one coat of Belzona 5811 and coat of Belzona 4311. Both were broadcasted with aggregate to rejection.

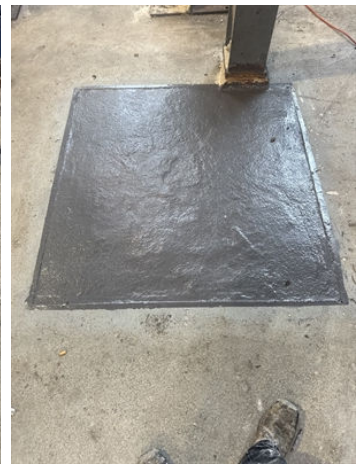
Repair completed with a final coat of Belzona 4311 to encapsulate the aggregate.
