BELZONA REPAIRS TO LARGE RUBBER LINED VALVE

Industry: Power
Application: VPF-Valves, Pipes and Fittings
Substrate: Cast iron.
Products: * Belzona® 2111 ,
* Belzona® 2121 ,

Customer Location: Power Station in Thailand.
Application Date: May 1996

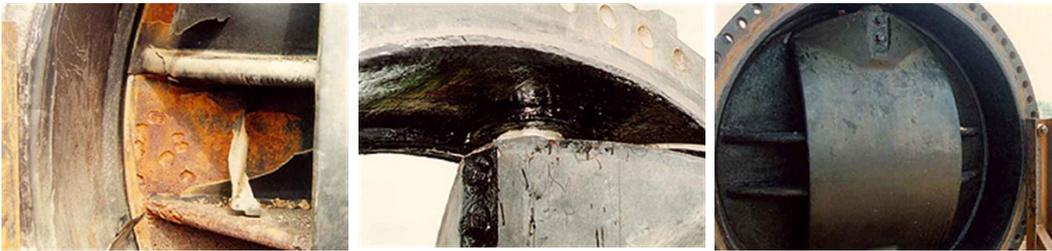
Photograph Descriptions

Premature failure of vulcanised rubber lining allowed severe erosion-corrosion of underlying steel after just three months in service.

- * Condition of the valve after just three months in service ,
- * Close-up of Belzona application showing encapsulation of bolts on valve disc ,
- * Completed application. ,

78-inch butterfly valve from cooling water system.

Application was carried out in accordance with Belzona® system leaflets VPF-1 & 2 and GSS-1.

The use of Belzona Elastomers allowed repairs to be carried out quickly on-site thus minimising disruption to the plant.
