# Belzona repairs Suction Bell

ID: 9901

Application: SHM-Solids Handling Machinery

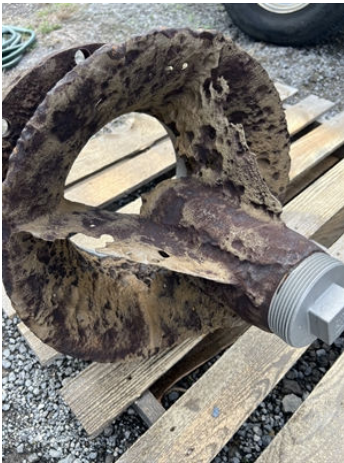
This suction bell he been in brackish water for over ten years and had not been taken out for service. They couldn't get a new suction bell in less than six months and the needed to be back up and running in two weeks.

Removing salts was a major priority in the first step of this repair.

We washed the suction bell with Salt-Away to remove the salts absorbed in the metal to achieve a 20pm or less. Once that was achieved we rebuilt and skimmed all pitted areas with Belzona 1111. Then we applied two coats of Belzona 1331.

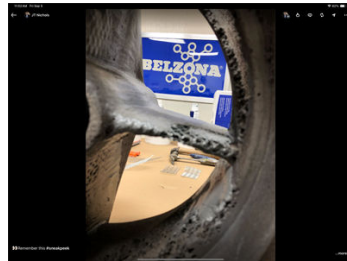
Making repairs using Belzona 1111

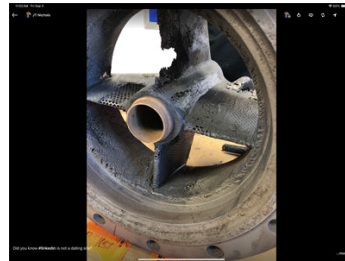
Here we are showing you a technique we use in the shop to fill voids and using Belzona 1111

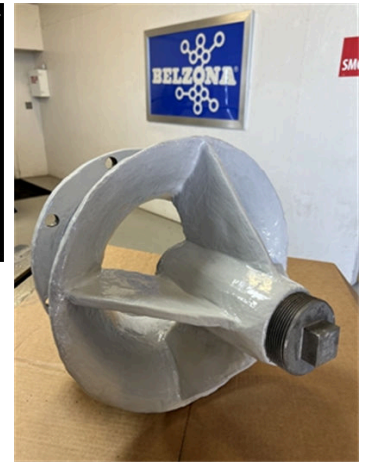
Finally we applied two coats of Belzona 1331 for a perfect finish.
