# Belzona repairs Suction Bell

ID: 9901

Application: SHM-Solids Handling Machinery

Customer Location: Decatur, AL

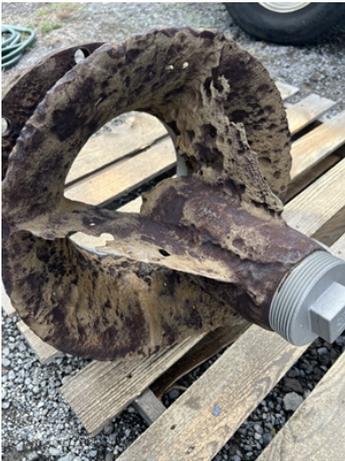
Removing salts was a major priority in the first step of this repair.

We washed the suction bell with Salt-Away to remove the salts absorbed in the metal to achieve a 20pm or less. Once that was achieved we rebuilt and skimmed all pitted areas with Belzona 1111. Then we applied two coats of Belzona 1331.

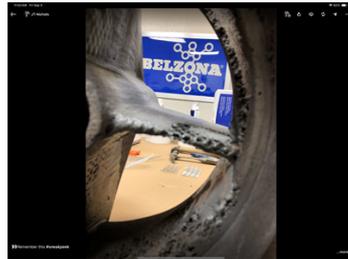
Making repairs using Belzona 1111

Here we are showing you a technique we use in the shop to fill voids and using Belzona 1111

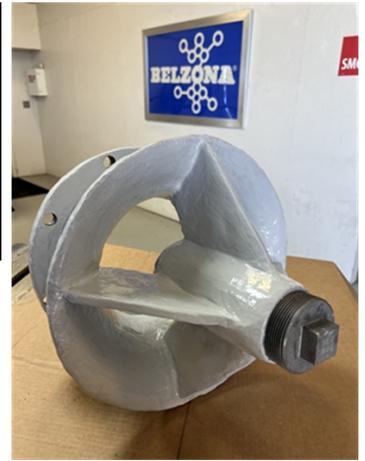
Finally we applied two coats of Belzona 1331 for a perfect finish.
