Permanent Leak Repair on Aging Lead and Oakum Pipe Joint

ID: 9902

Application: VPF-Valves, Pipes and Fittings

Customer Location: North Bay, Ontario

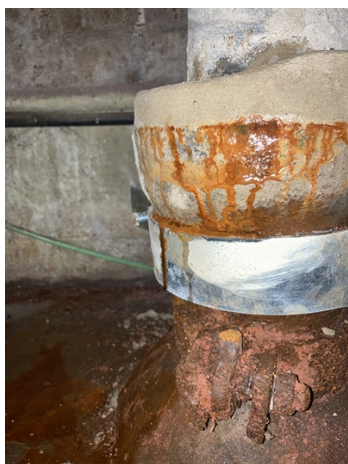
During the refurbishment of an old piping system within a commercial building, the customer discovered an active leak at a lead and oakum joint. These joints, common in older plumbing systems, had degraded over time, compromising the seal and allowing water to escape.

Leak through the hydraulic cement

Due to the age of the system and the joint's location, a full pipe replacement would have been costly and disruptive. The customer needed a reliable, long-lasting repair that could be done quickly without dismantling the existing pipework. They initially attempted to seal the leak with hydraulic cement, but the leak persisted, so a more robust solution was required.

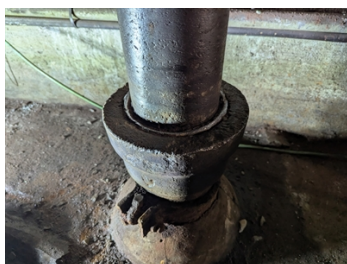
Hydraulic cement removed and pipe cleaned with power tools to bare metal

The failed hydraulic cement was first removed, and the area was cleaned and roughened using power tools to eliminate rust and create a suitable surface profile for bonding. Once the substrate was properly prepared, Belzona 4141 was applied to rebuild and level the surface around the joint. This created a solid and uniform base for the application of the Belzona SuperWrap II system, which was installed using three layers of reinforcing wrap to fully seal and strengthen the joint.

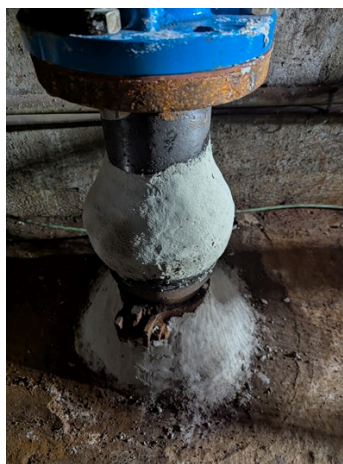
Belzona 4141 to smooth out transition area

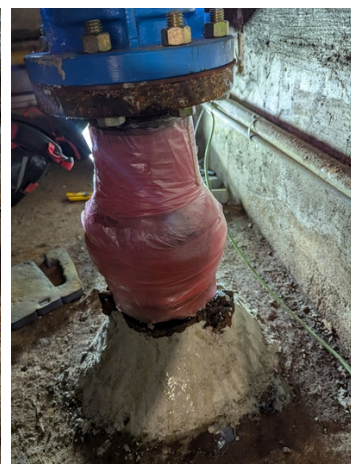
Full system wrapped and seal with Belzona SWII
