Permanent Leak Repair on Aging Lead and Oakum Pipe Joint

ID: 9902

Application: VPF-Valves, Pipes and Fittings

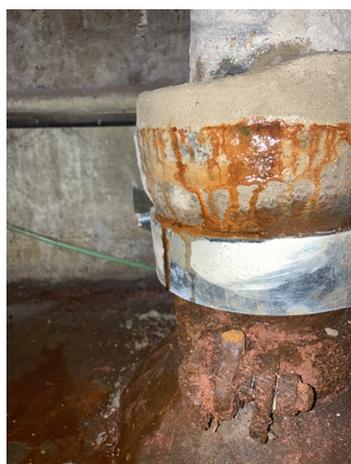
Leak through the hydraulic cement

During the refurbishment of an old piping system within a commercial building, the customer discovered an active leak at a lead and oakum joint. These joints, common in older plumbing systems, had degraded over time, compromising the seal and allowing water to escape.

Due to the age of the system and the joint's location, a full pipe replacement would have been costly and disruptive. The customer needed a reliable, long-lasting repair that could be done quickly without dismantling the existing pipework. They initially attempted to seal the leak with hydraulic cement, but the leak persisted, so a more robust solution was required.

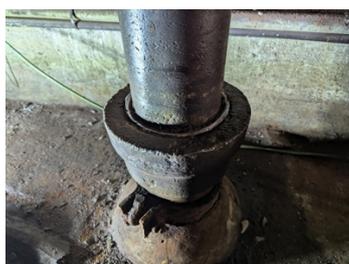
Hydraulic cement removed and pipe cleaned with power tools to bare metal

The failed hydraulic cement was first removed, and the area was cleaned and roughened using power tools to eliminate rust and create a suitable surface profile for bonding. Once the substrate was properly prepared, Belzona 4141 was applied to rebuild and level the surface around the joint. This created a solid and uniform base for the application of the Belzona SuperWrap II system, which was installed using three layers of reinforcing wrap to fully seal and strengthen the joint.

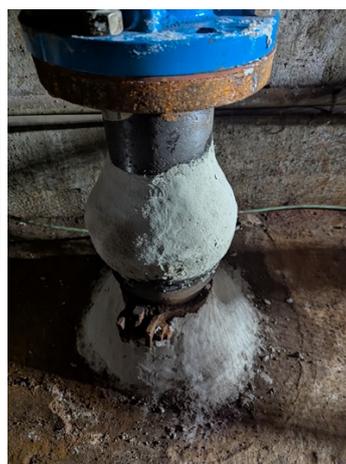
Belzona 4141 to smooth out transition area

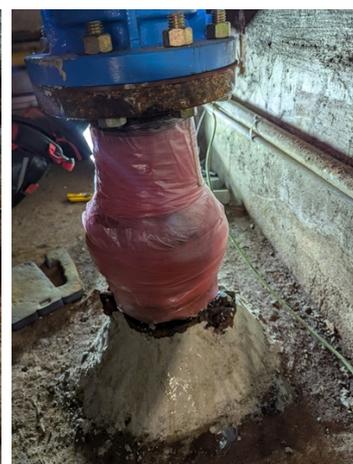
Full system wrapped and seal with Belzona SWII
