Belzona Rebuilds Flange Faces

ID: 9907

Industry: Chemical & Petrochemical
Application: GSS-Gaskets, Seals and Shims
Substrate: Carbon steel
Products: Belzona 1111 (Super Metal), Belzona 9411 (Release Agent)

Customer Location: Baytown, TX
Application Date: November 2023

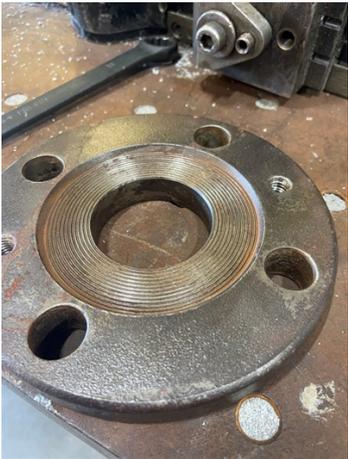
Close up on the flange before application.

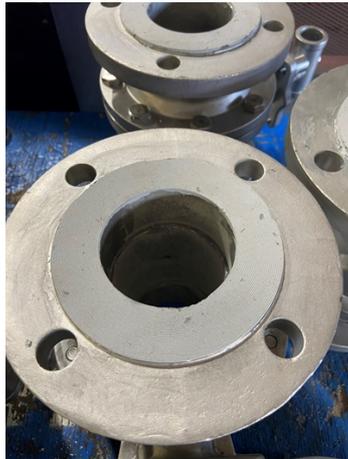
Close up picture on the flange after Belzona 1111 is applied and cured.

1. Power tool prep was completed using a grinder and cutting disk.
2. Belzona 9411 was used to apply on the fabricated former as a release agent.
3. Belzona 1111 was mixed and applied by brush to build up a ~.25" thick layer of product.
4. The former was applied and compressed the product. Once cured, the former was removed. The product was smooth and had a gramophone finish.

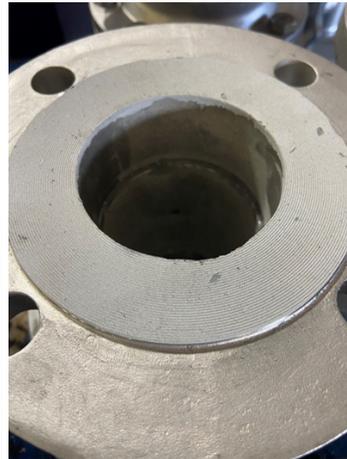
Closeup picture on the flange after Belzona 1111 is applied and cured.

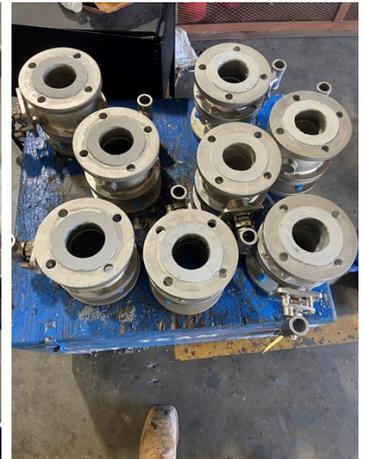
A number of flanges all rebuilt with Belzona 1111.
