Belzona Seals Cracks in Concrete Sump

ID: 9908

Industry: Chemical & Petrochemical
Application: TCC-Tanks and Chemical Containment Areas
Substrate: Concrete
Products: Belzona 4111 (Magma-Quartz), Belzona 4911 (Magma TX Conditioner), Belzona 5815
Customer Location: Baytown, TX
Application Date: September 2023

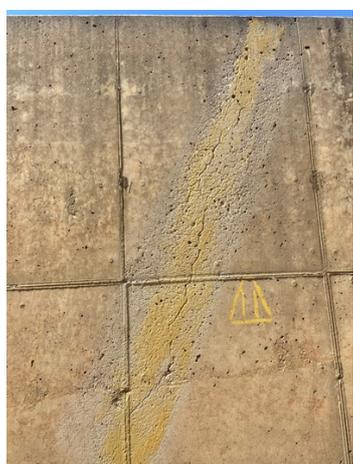
Crack in concrete along the wall of sump.

1. Power tool prep with grinders to vee out the cracks and prepare the concrete surface.
2. Apply Belzona 4911 conditioner
3. Apply Belzona 4111 to pit fill/rebuild lost concrete
4. Apply Belzona 5815 and 9371 to patch over the cracks

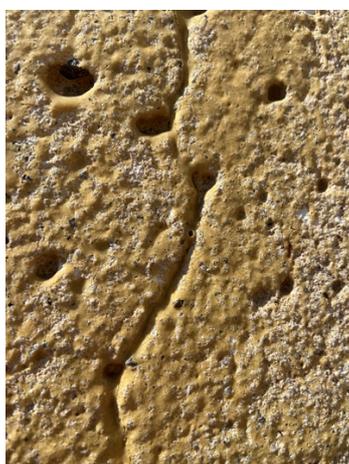
Close up photo of a defect in the sump wall.

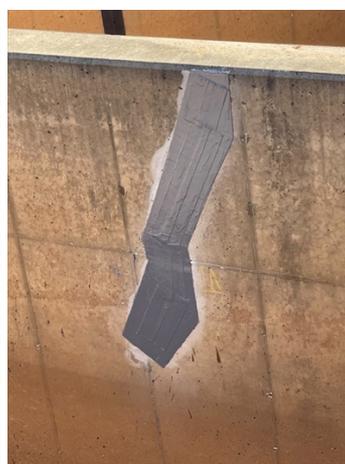
Belzona 5815 and 9371 crack repair on the application area.

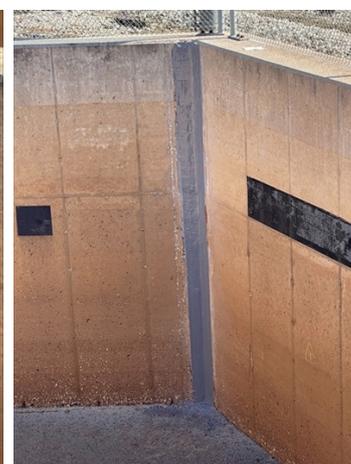
Floor to wall joint crack repair in grey, and existing previous Belzona crack repair in black still in good condition.

Customer needed a quick cost-effective solution to repair the cracks in concrete to add life to the sump. A previous Belzona repair was done 7 years ago and was still holding well, so they choose to use Belzona again in the repair areas.
