Belzona Protects Sulfuric Acid Containment

ID: 9910

Industry:	Chemical & Petrochemical	Customer Location:	Conroe, TX
Application:	TCC-Tanks and Chemical Containment Areas	Application Date:	October 2023
Substrate:	Concrete		
Products:	Belzona 4124 (Bulkfill), Belzona 4311 (Magma CR1), Belzona 5811 (Immersion Grade)

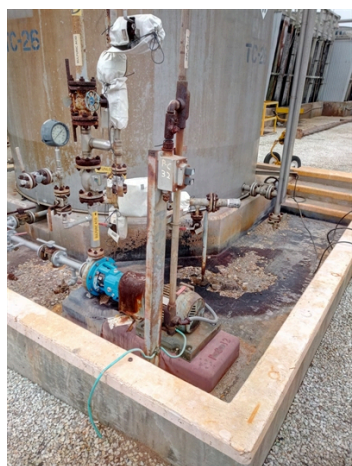
Client has a concrete sulfuric acid containment near a cooling tower. The concrete has damage from spills / leaks of the 98% sulfuric acid into the non coated concrete and from always being wet in TX humidity & nearby cooling tower mist. The acid and moisture have caused cracks & spalling in the concrete over time. The customer wanted a long term solution to protect the concrete.

Acid containment with damage in concrete before application

1. A containment was built around the concrete containment.
2. The concrete was vapor blasted to roughen the concrete and create an optimal profile to bond to.
3. Belzona 4124 was used to rebuild lost concrete on the containment floor in the damaged areas.
4. First coat of Belzona 5811 was applied with nonskid to create a non-slip surface.

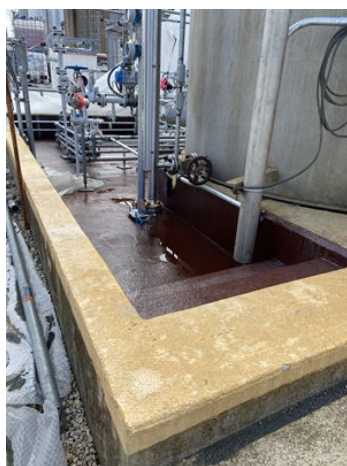
Belzona 4311 applied into containment

5.☑Belzona 4311 was applied as the top coat for long term protection against chemical attack.

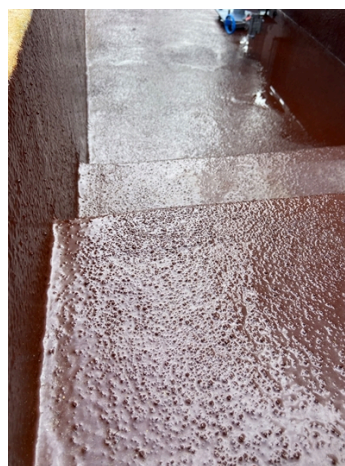
Close up on coating with non skid aggregate

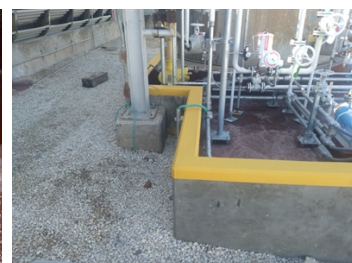
About 1.5 years after install we completed a visual inspection of the coating and it was still in good condition.

At the 1.5 year follow up inspection the coating was in excellent condition. The area showed no spalling, cracking, or delamination of coating. The customer is happy. If a facility has a spill of acid into ground soil it can cause extreme fines and shutdown of the facility. This Belzona repair helps protect from that happening.
