# Belzona 1121 Pit Fills Skid

ID: 9913

Industry: Oil & Gas  
Application: FPA-Floor Problem Areas  
Substrate: Carbon steel  
Products: Belzona 1121 (Super XL-Metal), Belzona 9111 (Cleaner Degreaser)

Customer Location: Houston, TX  
Application Date: August 2023

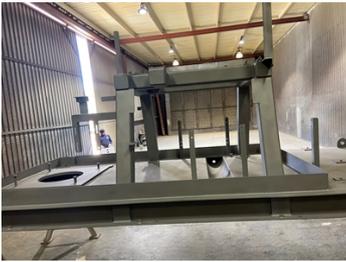
Skid overview

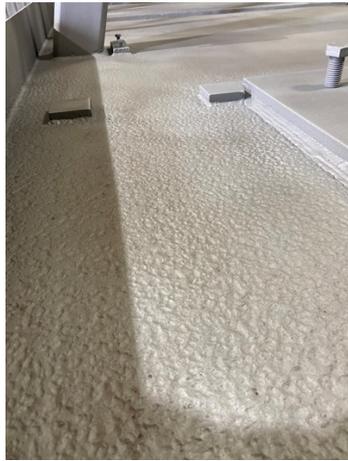
Skid after abrasive blasting

1. Abrasive blast was used for surface preparation (SSPC-SP10)
2. Substrate was wiped clean with Belzona 9111 and let dry.
3. Belzona 1121 25kg kit was mixed and applied to the application area. A Belzona applicator was used to trowel on product and fill in pitting.

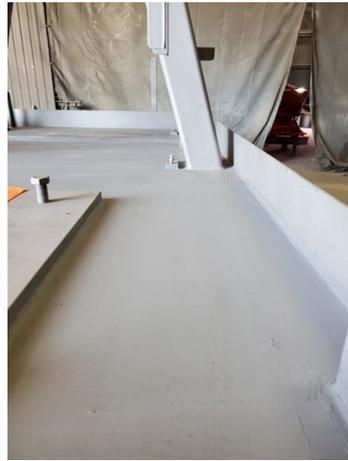
Belzona 1121 applied and smoothed over pitting

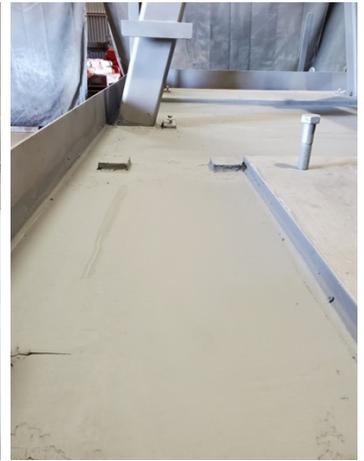
Belzona 1121 applied and smoothed over pitting
