# Belzona Rebuilds & Protects Chiller Head Cover

ID: 9914

Application: HEX-Heat Exchangers

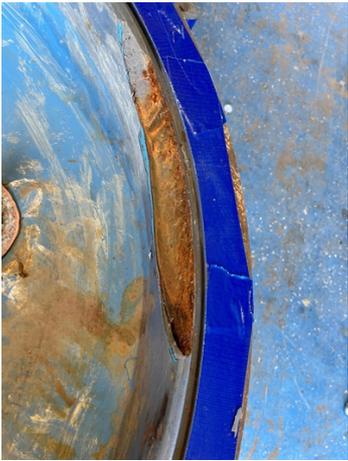
Client was completing the annual maintenance on their chillers and noticed damage on the end covers. The asset was previously lined by a competitor to Belzona, and it was failing around the edge. A chunk of the end cover came off which caused concerns. The previous coating was delaminating, metal loss was occurring and made it unsafe to put back into service.

Defect area

1. Power tool prep to remove loose adhered coating and roughen up metal (SSPC-SP11)
2. Substrate was wiped clean with Belzona 9111 and let dry.
3. Belzona 1121 was applied to rebuild lost metal.
4. Belzona 1321 applied in a two coat system

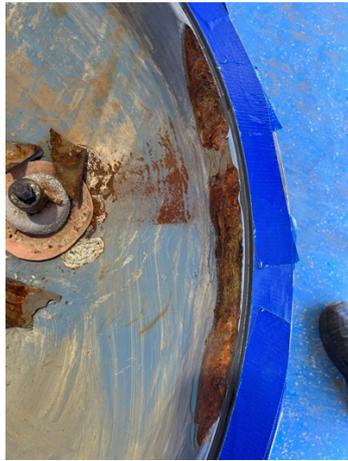
Defect area #2

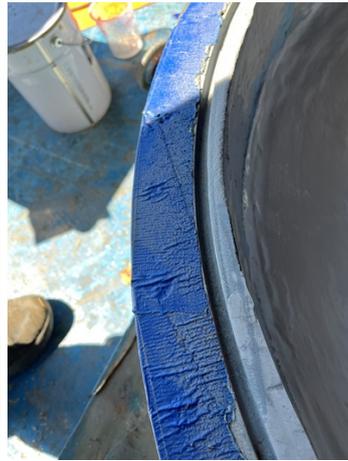
Rebuilt edge

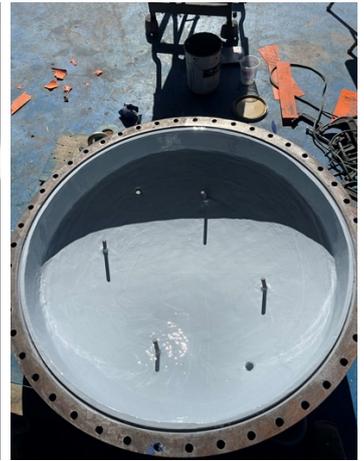
Final result with two coat system of Belzona 1321
