Groundwater leaks into jet fuel pipe repair

ID: 9916

Industry: *Transport* Customer Location: *Baton Rouge LA*
Application: *WPA-Wall Problem Areas* Application Date: *July 2025*
Substrate: *Concrete*
Products: *Belzona 4141 (Magma-Build), Belzona 4911 (Magma TX Conditioner), Belzona 5815*

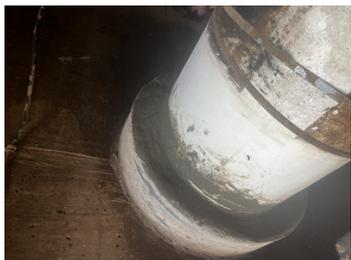
Groundwater was entering around a jet fuel pipe penetration, causing the vault to fill up with water.

Leaking pipe penetration

Cleaned up area with 5,000 psi pressure washer wiped down with MEK. Applied Belzona 4911 conditioner, applied Belzona 4141 to penetrating areas to build up to a transition. Applied Belzona 5815 with Belzona 9311 reinforcing sheet twice. Went back the next day and no leaks.

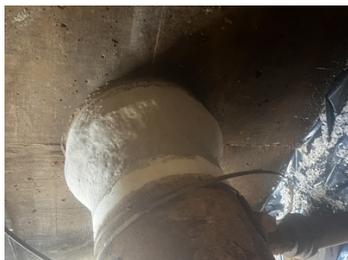
Building up around pipe from concrete with Belzona 4141
