DRIVE ROLLER GETS BELZONA GRIP SYSTEM

Application: SHM-Solids Handling Machinery

Customer Location: Cement plant, Bulgaria

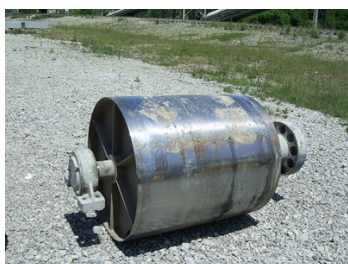
The drive roller had no lagging and was exposed to the weather conditions causing loss of grip and slippage.

- * Roller prior to application ,
- * Surface preparation by blasting ,
- * Chevron pattern was created ,
- * Completed application ,
