# DRIVE ROLLER GETS BELZONA GRIP SYSTEM

Industry: *Cement*  
Application: *SHM-Solids Handling Machinery*

Customer Location: *Cement plant, Bulgaria*  
Application Date: *June 2006*

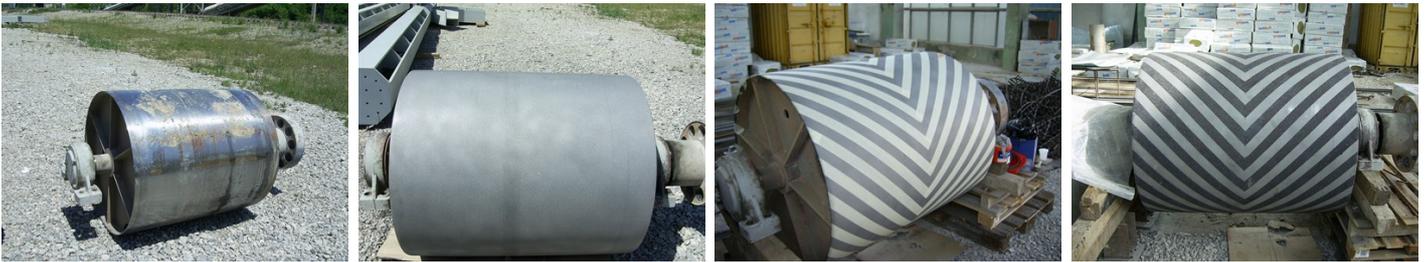
## Photograph Descriptions

*The drive roller had no lagging and was exposed to the weather conditions causing loss of grip and slippage.*

- \* Roller prior to application ,
- \* Surface preparation by blasting ,
- \* Chevron pattern was created ,
- \* Completed application ,

Conveyor belt drive roll with diameter 1000 mm.

Application was carried out in accordance with Belzona Know-How System Leaflet SHM-12.

Belzona solution was half the cost and faster to apply than conventional hot vulcanization. The roll was prepared and the system applied without leaving the facility. At the end of 2007, the system is still in perfect condition and the client is considering application to another unit.
