Belzona repairs Community changing room container

ID: 9920

Industry: Local Authorities & Municipalities
Application: WPA-Wall Problem Areas
Substrate: Aluminum
Products: Belzona 3121 (MR7)

Customer Location: Nottingham
Application Date: March 2025

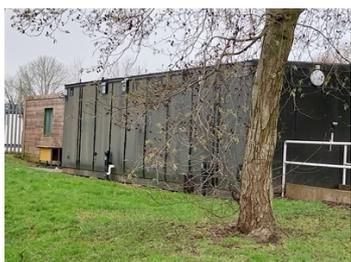
A community Junior football team were using a modified container as their main changing and shower facility. The roof and walls were found to be letting in rain water and needed to be sealed

The container on first inspection

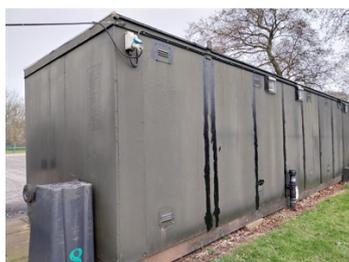
Showing previously failed repairs

High pressure wash all joints and remove as much of the previous failed repair as possible

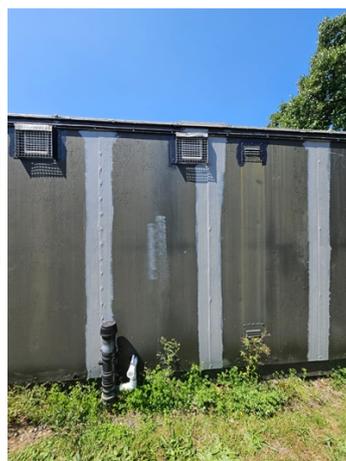
Belzona repairs carried out by one of the client's contractors

Wire brush all target areas to remove any loose, rusty and dirty particles

Clean down all target area with Belzona 9111

Mix and apply 2 x coats of Belzona 3121 incorporating Belzona 9331 reinforcing sheet to all target areas on walls and roof

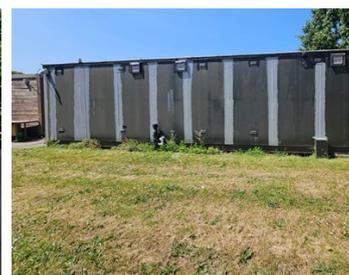
Container walls and roof resealed with Belzona 3121
