Internal Rehabilitation of Heat Exchanger Using Belzona 1111 & 1321

Application: HEX-Heat Exchangers

Substrate: Carbon steel

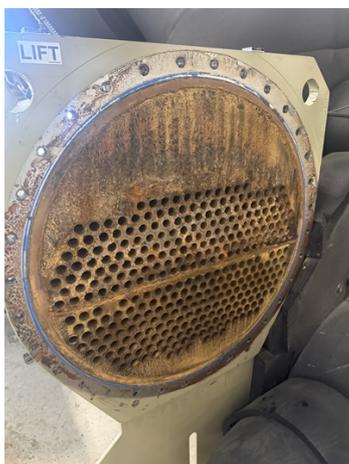
Initial condition of the heat exchanger showing severe corrosion and rust accumulation on the tube sheet surface.

The customer was experiencing severe internal corrosion in the heat exchanger's tube sheets, covers, and water box. Oxidation had caused metal loss, flaking, and surface degradation, threatening the unit's structural integrity and performance. There was concern about potential leakage and the high cost of replacement.

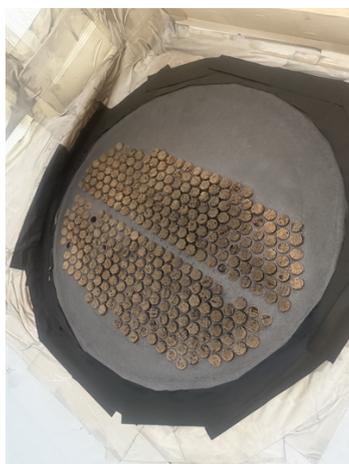
Surface after abrasive blasting, showing a clean and profiled tube sheet ready for application. Tubes protected using corks.

The internal surfaces were abrasive blasted to obtain a clean and rough surface with an anchor profile of approximately 3 mils. A chloride contamination test was performed after blasting to confirm surface suitability. Degreasing was then carried out using Belzona 9111. Areas with visible metal loss or damage were rebuilt using Belzona 1111 (Super Metal). After the rebuilding process, Belzona 1321 (Ceramic S-Metal) was applied in two coats, grey followed by blue, to ensure full coverage and long-term corrosion protection.

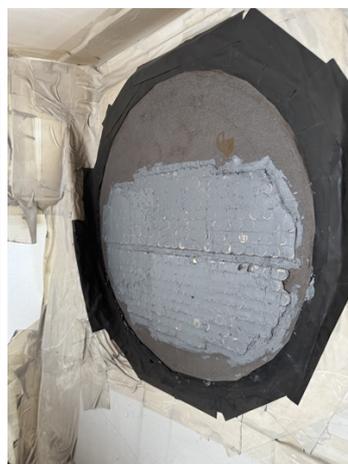
Rebuilding damaged areas using Belzona 1111 (Super Metal) to restore metal loss and ensure structural integrity.

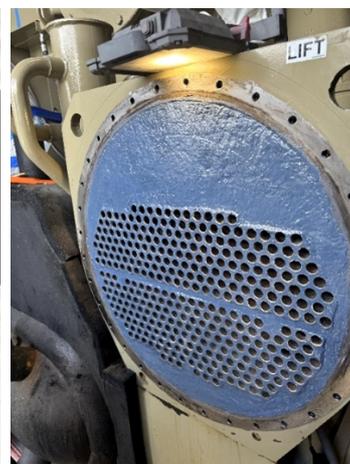
Completed application of Belzona 1321 in two coats with plugs removed, revealing a smooth and fully protected tube sheet surface.
