NSF-Approved Repair of Perforated Pipe in Potable Water System

ID: 9924

Application: TCC-Tanks and Chemical Containment Areas

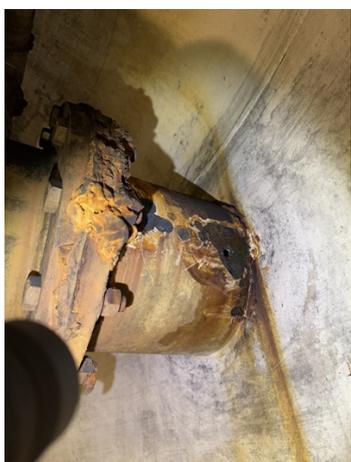
A municipality discovered a perforation in a carbon steel pipe feeding a pressure vessel containing granular activated carbon. The pipe, which conveys potable water with 4 ppm hydrogen peroxide, had suffered coating failure and internal corrosion. With the system needing to be operational within two weeks, the municipality sought a repair method that would minimize downtime and avoid hot work, while being suitable for continuous immersion in drinking water.

Problematic area showing the through wall defect

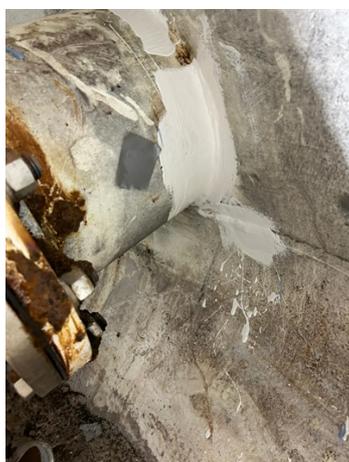
Cold bonding repair completed and through wall defect sealed

After abrasive blasting to remove corrosion and failed coating, the surface was cleaned and prepared to the required profile. Belzona 1111 was used as a cold bonding solution to bond a steel plate over the perforated area, sealing the defect and reinforcing the weakened section of the pipe. The bonded area was then overcoated with Belzona 1341N, providing long-term protection for potable water service under continuous immersion conditions.

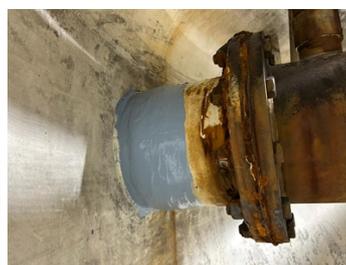
Full repaired section protected with Belzona 1341N

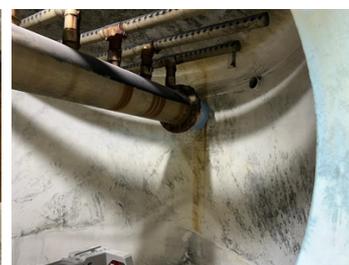
View from the tank's manhole of the repaired section
