# Worn shaft gets the Belzona former treatment

ID: 9926

Industry: Heating, Ventilation & Air Conditioning  
Application: MPT-Mechanical Power Transmission

Substrate: Carbon steel  
Products: Belzona 1111 (Super Metal), Belzona 9411 (Release Agent)

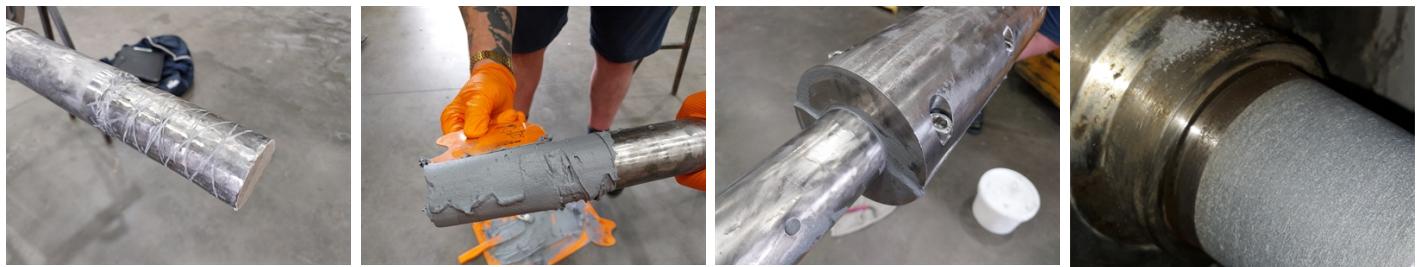
A misaligned bearing on a shaft caused excessive wear and damaged the shaft beyond normal working limits

Damaged shaft, prepared using a grinder/cutting disc, then degreased and cleaned using Belzona 9111

After wetting out the former and prepared shaft, the Belzona 1111 was applied using an applicator

The former was put into place and the bolts tightened to extrude the excess Belzona and leave no air entrapment

A rare opportunity to see the repair some months on, still showing perfect working geometry whilst now fitted into the machine

Shaft abraded with grinder/cutting disc  
Belzona 9111 used to clean and degrease  
Belzona 9411 release agent applied to former and parts of shaft adjacent to target area  
Former and shaft "wetted" out with Belzona 1111 using a short bristled brush  
Belzona 1111 applied to shaft using applicator  
Former located onto the shaft and tightened  
Allow for curing  
Remove former and dress using fine emery paper

Having been invited to return to see a refit of the repair the shaft is working well and ready for further bearing fits
