Belzona repairs hospital shower

ID: 9927

Industry: *Buildings & Structures*
Application: *FPA-Floor Problem Areas*
Substrate: *Masonry*
Products: *Belzona 5815, Belzona 9111 (Cleaner Degreaser)*

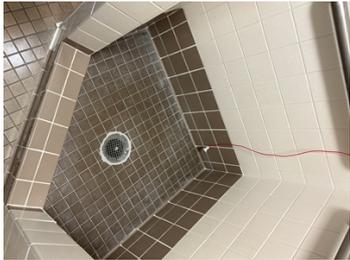
Patient rooms shower floors leaking

Shower floor before

Patient shower floor was leaking when showers were being used. This was causing ceiling tile to be wet on the floor beneath and causing bacteria and having to close patient rooms. Belzona was as ample to do two rooms and release them back in 24 hours.

Application was prepped by angle grinder with diamond ad with dust collector. Wiped down with cleaner, degreaser. Applied two coats of Belzona 5815 according to IFU incorporating aggregate.

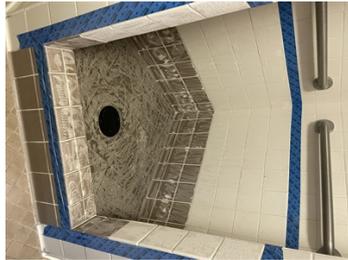
Shower floor during surface preparation
