# Belzona Elastomers Save the Day on this Crane Track Repair

ID: 9931

Industry: *Mining & Quarrying*  
Application: *SHM-Solids Handling Machinery*

Substrate: *Rubber*  
Products: *Belzona 2211 (MP Hi-Build Elastomer), Belzona 2221 (MP Fluid Elastomer), Belzona 2911 (Elastomer QD Conditioner)*

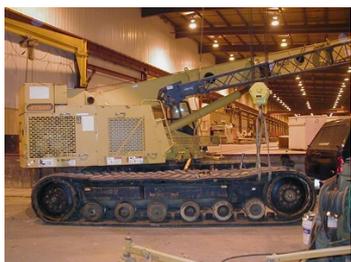
Crane

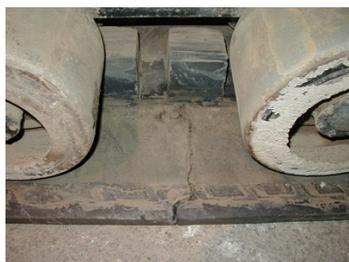
*The rubber track for this crane was almost cut in half*

Close up of the damaged rubber track of a crane

This crane track came apart on a jobsite and a quick solution was needed to get them up and running. The Belzona solution had them back at work the next morning.
