Cavitation Repair of Runner Blades Using Belzona Solutions

ID: 9932

Industry: Power
Application: FBC-Fans, Blowers and Compressors

Customer Location: Ontario, Canada
Application Date: May 2025

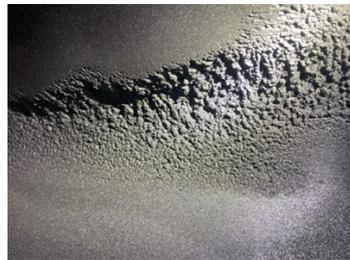
A hydroelectric facility was experiencing severe cavitation damage on the runner blades of a unit. The affected areas showed significant material loss, particularly at the blade-to-band transition zone on the suction side, where cavitation effects are most aggressive. This wear threatened operational efficiency and long-term equipment integrity.

Section of the runner affected by cavitation

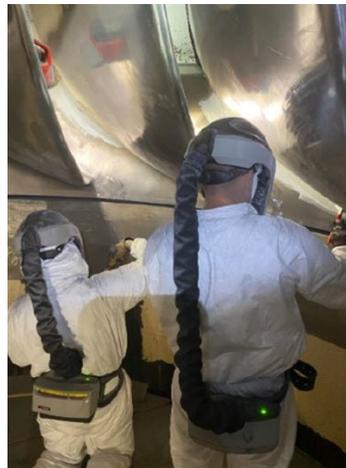
Substrate after surface preparation via abrasive blasting

The repair process began with surface preparation, where the runner blades were blasted using stainless steel media to avoid rust contamination from carbon steel grit. Belzona 1161 was then used to rebuild the damaged areas on all 15 blades, restoring the lost metal and surface profile. A second coat of 1161 was applied to about 7 blades to fill remaining voids or imperfections. After curing

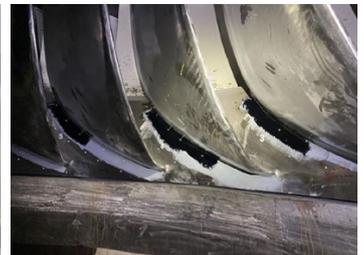
Application of 1st coat of Belzona 1341

for 3–4 hours, the repaired surfaces were sanded and blended to match the original blade contours. Once the rebuilding phase was complete, Belzona 1341 was applied to all blades to provide a smooth, hydrophobic, and erosion-resistant finish. After curing, Belzona 2941 conditioner was applied to the areas designated for additional cavitation protection and left to cure for 8 hours. Belzona 2141 was then applied in a controlled manner over the critical cavitation-prone zones. Following the application, the facility's Asset Integrity Management team performed a 3D scan of the runner to establish a baseline for future monitoring and wear assessments.
