Valve Body Assembly protected with Belzona

ID: 9935

Industry: Water / Wastewater
Application: CEP-Centrifugal Pumps
Substrate: Carbon steel
Products: Belzona 1111 (Super Metal), Belzona 1321 (Ceramic S-Metal)

Customer Location: Cape Town
Application Date: July 2018

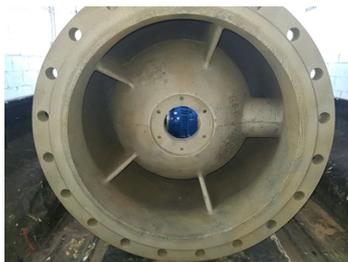
The valve assembly had damage on it from erosion of years of use in the water industry. Most of the machine surfaces had to be repaired using Belzona.

Valve body assembly arriving for preparation and application

The internal surfaces were abrasive blasted to obtain a clean and rough surface with an anchor profile of approximately 3 mils. A chloride contamination test was performed after blasting to confirm surface suitability. Degreasing was then carried out using Belzona 9111. Areas with visible metal loss or damage were rebuilt using Belzona 1111 (Super Metal). After the rebuilding process, Belzona 1321 (Ceramic S-Metal) was applied in two coats, grey followed by blue, to ensure full coverage and long-term corrosion protection.

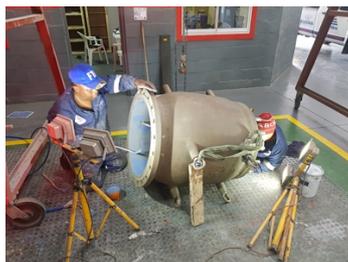
First coat of Belzona 1321 being applied

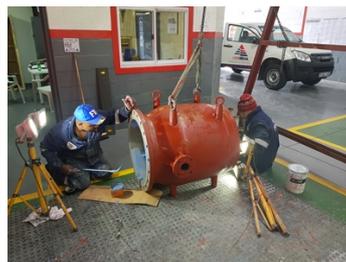
Second coat of Belzona 1321 being applied

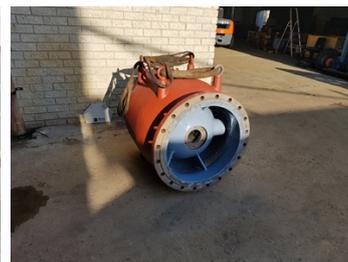
Valve body assembly done
