Excavator external fuel tank

ID: 9936

Industry: Mining & Quarrying
Application: TCC-Tanks and Chemical Containment Areas
Substrate: Carbon steel
Products: Belzona 5811 (Immersion Grade)

Customer Location: Oklahoma
Application Date: March 2023

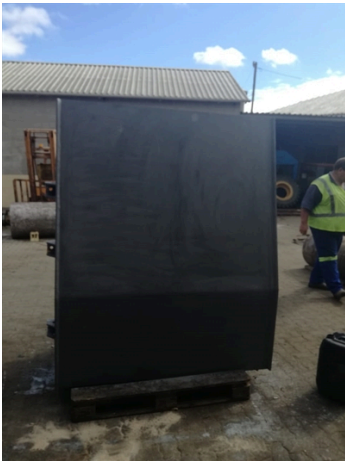
Excavator external fuel tank had rust and pitting on the outside of the tank from years of work in the mining industry. It was painted for years but it was still rusting.

Tank prior to application

The outside surfaces were abrasive blasted to obtain a clean and rough surface with an anchor profile of approximately 3 mils. A chloride contamination test was performed after blasting to confirm surface suitability. Degreasing was then carried out using Belzona 9111. Belzona 5811 was, then, utilized to provide corrosion protection.

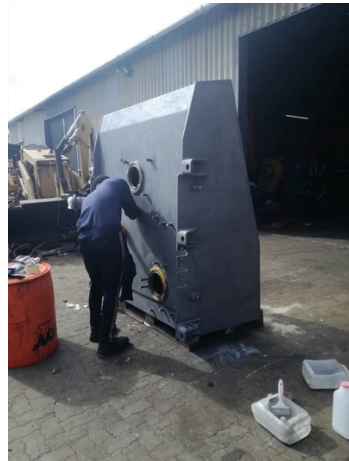
First coat with Belzona 5811

Removed all paint, tar, or any other applied coating, loose surface material, grease, oil, dust, and laitance. Degreased the area, then prepared it via abrasive blasting. Applied Belzona 5811 directly on to the prepared surface with a short-bristled brush. As soon as possible, the second coat of Belzona 5811 was applied.

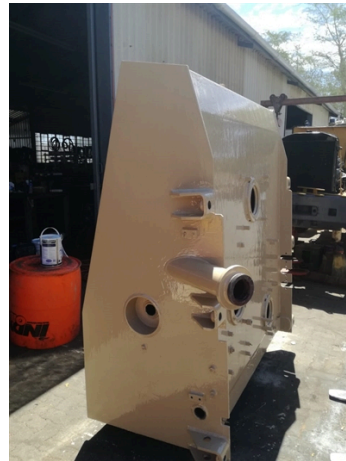
Second coat with Belzona 5811

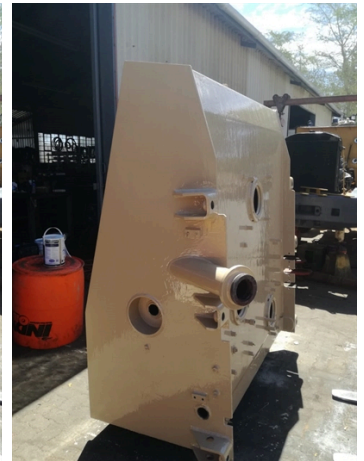
Finished application
