Overhead repairs to spalled balconies

ID: 9939

Application: WPA-Wall Problem Areas

Substrate: Concrete

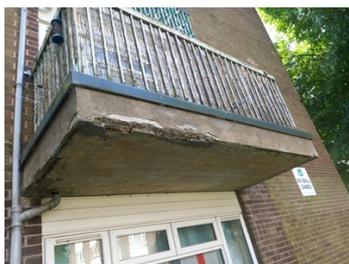
A number of balconies had started to spall and were listed as dangerous, needing urgent attention

Badly spalled concrete to under-ledge of balcony

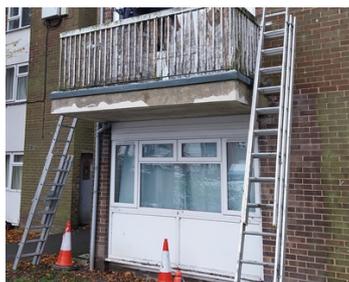
Work in progress

Break off any loose and friable faulty, spalled concrete

Wire brush all exposed repair back to clean steel

Mix and apply Belzona 4911 to the target areas with a short bristled brush

Mix and apply Belzona 4141 to target areas using a board, coated with Belzona 9411 release agent, as a straight edge

Compress and smooth using a finishing trowel

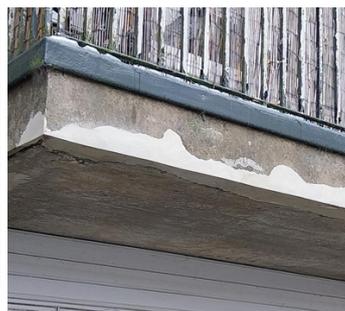
18 months on, the repairs are still in perfect condition

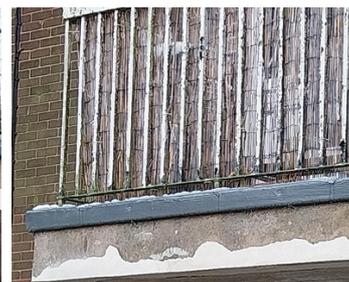
A further angle, showing 1 of 20 successful concrete repairs, some 18 months later
