# BELZONA FLOOR REPAIR 24 YEARS ON

Industry: Buildings & Structures  
 Application: FPA-Floor Problem Areas  
 Substrate: Concrete  
 Products: \* Belzona® 4111 (Magma Quartz) ,

Customer Location: Auto manufacturer, Wentzville, MO  
 Application Date: Summer 1984

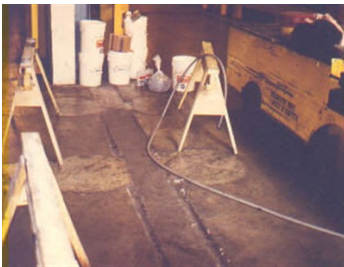
*Rough area caused vehicles to lose their load, creating a safety hazard and damage to package contents. In addition, the rough ride damaged sensitive electronic equipment.*

- \* Original floor in 1984 ,
- \* Belzona® 4111 application completed ,
- \* Belzona® 4111 in February 2008 ,

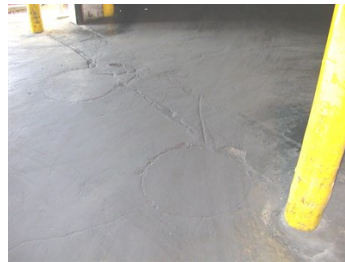
Safety concerns were paramount. One single piece of damaged electronics far surpassed the cost of the entire Belzona application. After 24 years, there is some slight damage, but the floor is still performing satisfactorily.
