Belzona repairs underfloor cast church water pipe

Industry: Local Authorities & Municipalities
Application: VPF-Valves, Pipes and Fittings
Substrate: Cast Iron
Products: Belzona 1212, Belzona 9111 (Cleaner Degreaser)

Customer Location: Burton upon Trent
Application Date: July 2021

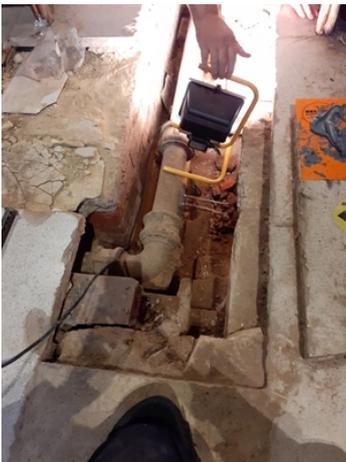
The pipes under the floor, now isolated and the water removed. The leak was still weeping

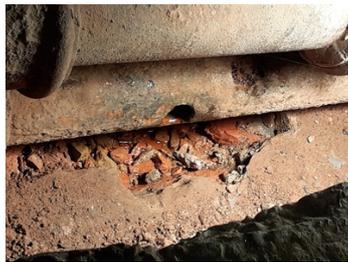
The throughwall was identified as a large hole in the side of the main 4" pipe

Water was accumulating on the church floor, which appeared to be emanating from under the floor itself. The floor was lifted and a large hole was identified in the cast iron mains water pipe.
