# High Visibility Marking for fall Hazard

ID: 9942

Industry: Water / Wastewater

Application: FPA-Floor Problem Areas

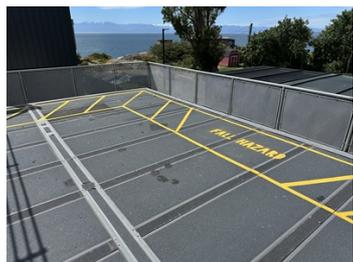
High visibility markings identifying fall hazard

The areas were masked off in neat and tidy lines and a template was made indicating 'FALL HAZARD' as specified by the safety teams. Belzona 5231 was applied by brush and roller and Belzona 9231 Surefoot Aggregate was broadcasted to rejection. A final coat of Belzona 5231 was applied as a top coat.

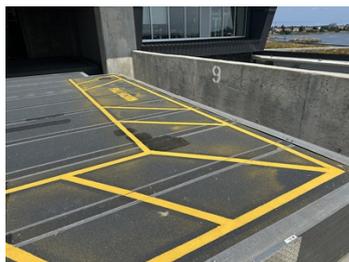
Clean lines, 3 coats total were applied

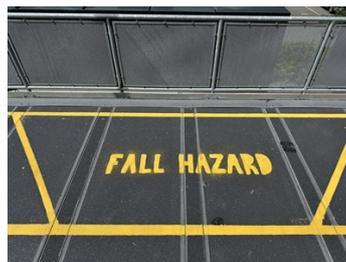
Text application using custom stencil

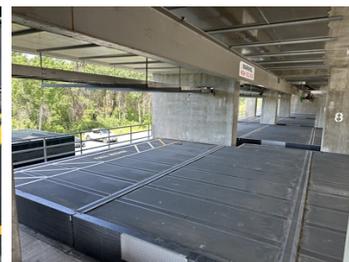
A total of 7 tank lids were completed
