Belzona saves settlement tank on large Holiday Complex

ID: 9943

Industry: Commercial Facilities
Application: TCC-Tanks and Chemical Containment Areas
Substrate: Other
Products: Belzona 1111 (Super Metal), Belzona SuperWrap II, Belzona 5831 (ST-Barrier), Belzona 9111 (Cleaner Degreaser)

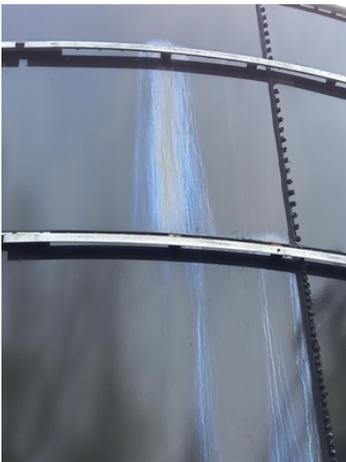
Leaks showing throughwall on large settlement tank

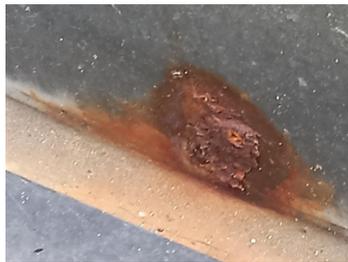
General throughwalls found around the tank

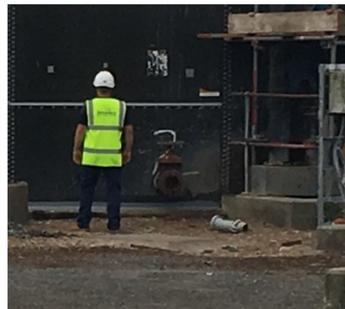
Belzona application services assessing the plan and application

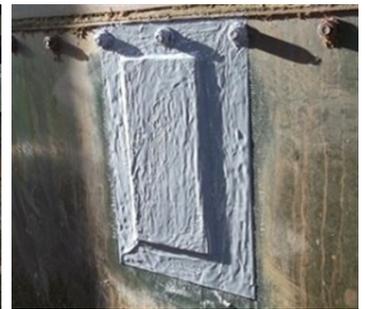
An example of one of the repairs

Prepare substrate using 80 grit emery

Mix Belzona 1111 and wet out the target and rear side of Belzona SuperWrap II composite patch

Build up Belzona 1111 to a peak on the patch and press onto the damaged area, securing with straps, magnets or sprag

Mask up the area and apply Belzona 5831 Barrier coating to repair area
