# Belzona protects Containment Area in a Wastewater plant

ID: 9947

Industry: *Water / Wastewater*  
Application: *TCC-Tanks and Chemical Containment Areas*  
Substrate: *Concrete*  
Products: *Belzona 5815*

Customer Location: *Victoria, BC*  
Application Date: *June 2025*

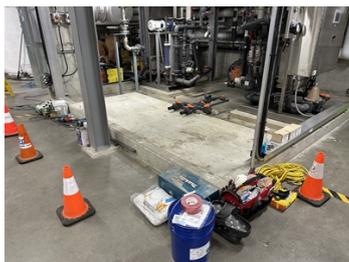
*A recent leak in the containment area had water penetrating through cracks in the concrete into an electrical room below.*

Photo of containment area with storage tanks removed

The concrete was ground using diamond cup grinders with hepa-vac systems. Two coats of Belzona 5815 were applied by brush & roller.

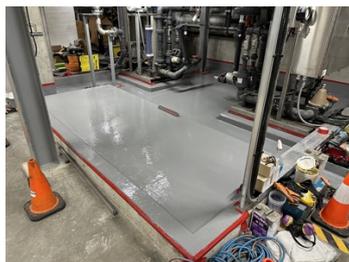
Application in progress

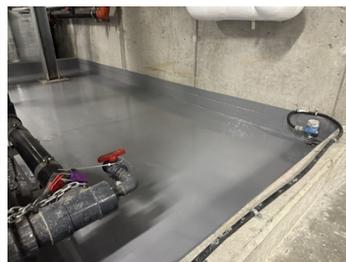
View of containment area

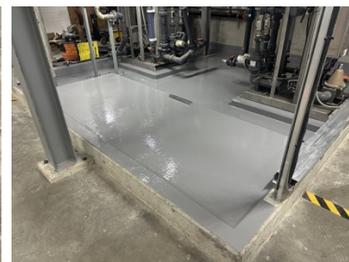
Finished application
