Repairs to concrete fuel store floor

ID: 9949

Application: FPA-Floor Problem Areas

Substrate: Concrete

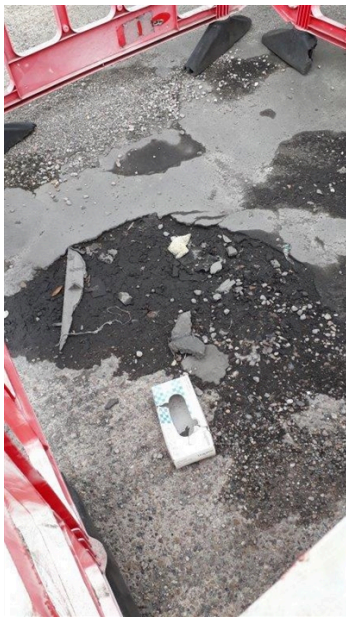
Repeat impact from the dropping of Oxygen cylinders, along with heavy lorry wear and tear had broken up large areas of the fuel store at a large distribution center

Broken floor with large holes and cracks due to impact

The Belzona application was carried out in one day and was returned to service the following day after that, giving a turnaround of just 2 days. The alternative would have taken much longer and also necessitated the saw-cutting and breaking out to cast new concrete, which would then have had to be left for a number of weeks to fully set

Break out loose and friable materials and vacuum

Apply Belzona 4911 to all target areas

Mix and apply 4151 resins and 4111 aggregates

Trowel off to compress and leave to cure

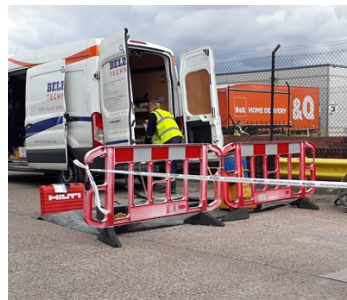
Works taking place to repair the damage

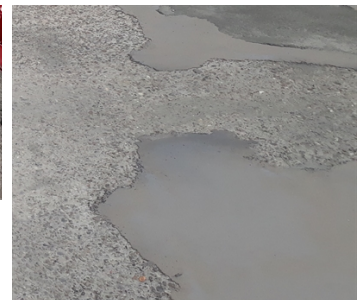
6 years on

ongoing operations of the distribution warehouse.
6 years on, the repairs are still performing as intended
